# Dry Creek Bank Erosion Management Plan

Roseville, California

**July 14, 2003**

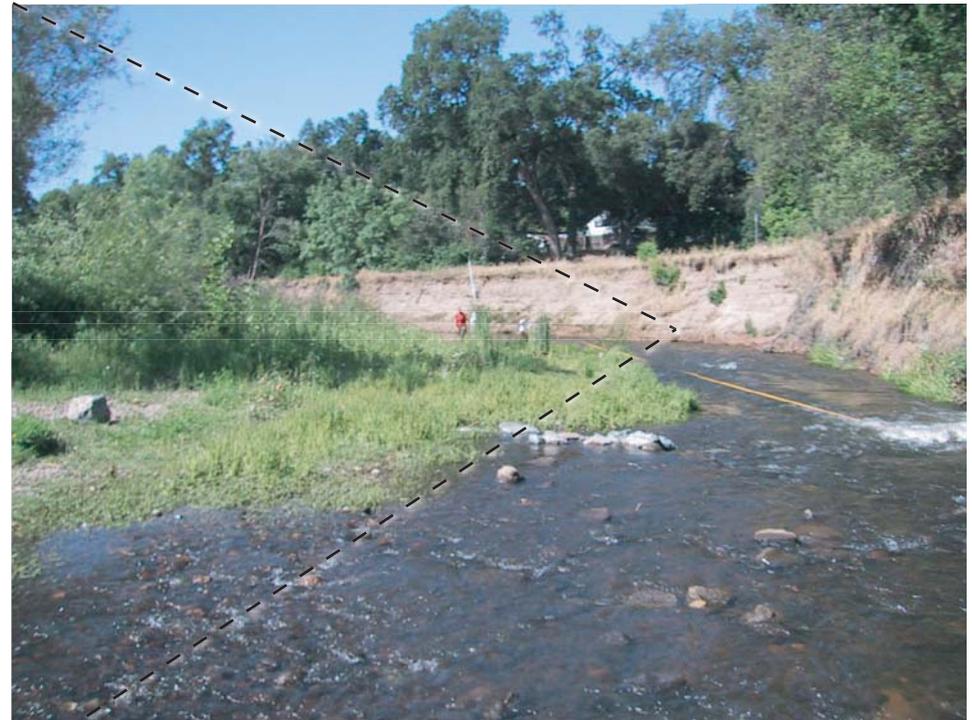
Photo of Site 29R looking downstream

**Figure 6 - Composite Failure**

Site 29R is located downstream of the Douglas Boulevard Bridge. A sudden decrease in bed slope, coupled with a wider channel relative to the adjacent reach upstream, allows elevated stream flows to decrease both water depth and velocity in this location. These hydraulic characteristics result in sediment deposition and bar formation on the left side of the channel. The presence of the bar diverts low flows into the exposed, unvegetated bank (shown in the close-up above), causing chronic undercutting at the toe and slab failure of the lower bank. This is a natural response to re-establish a meander, increase channel length, and create geomorphic complexity. The upper bank is composed of loose, sandy hydraulic mining debris and experiences chronic shallow failure. Future bank stabilization at this site will preserve the established meander pattern while providing bioengineering toe protection to reduce bank erosion.

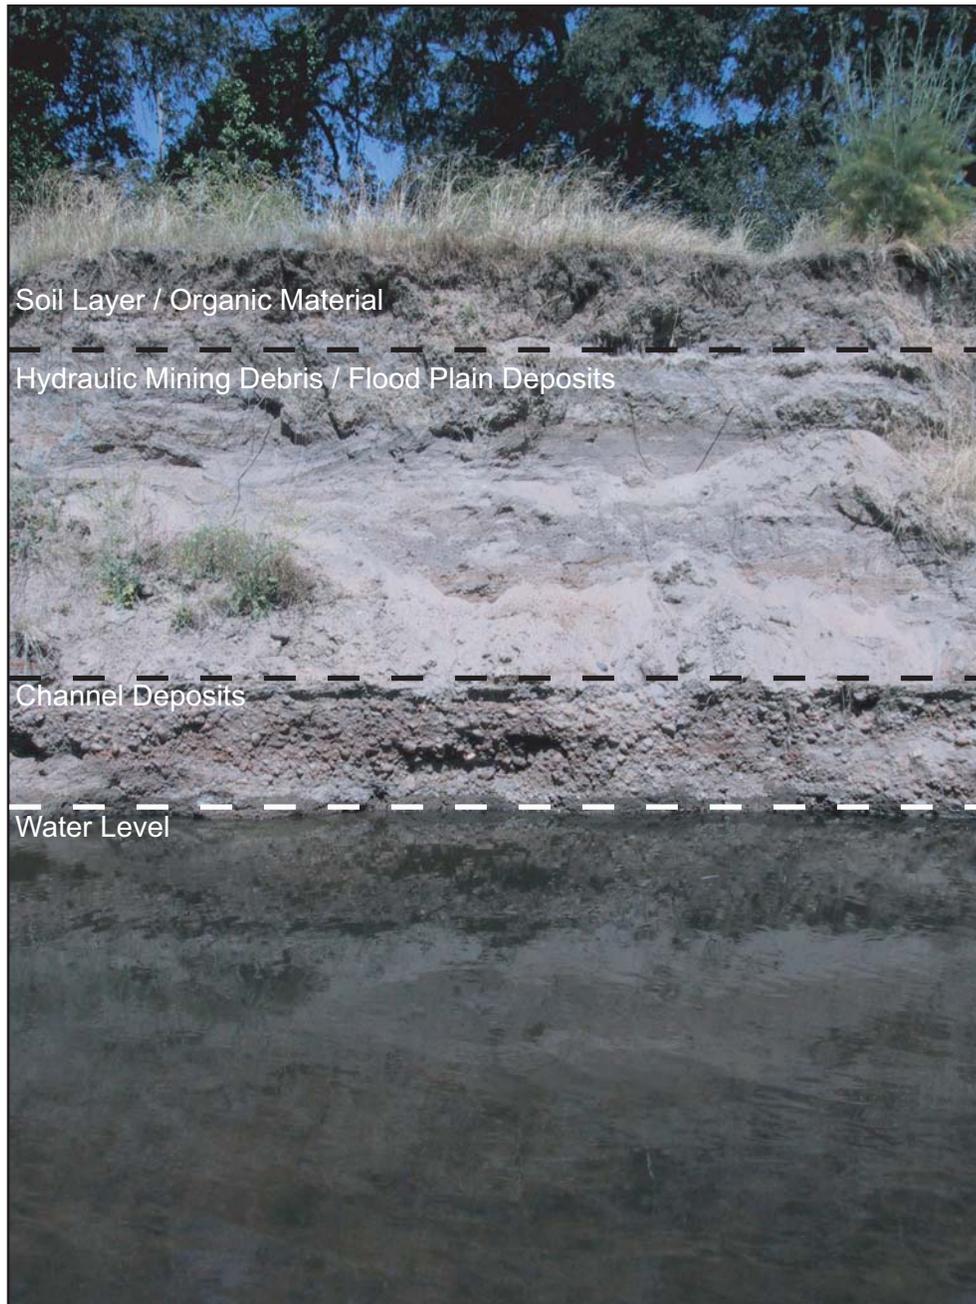
**Figure 7:** Photo illustrating the three distinct geologic materials composing the Dry Creek stream banks. (Taken Spring, 2002 at Erosion Site 29R.)

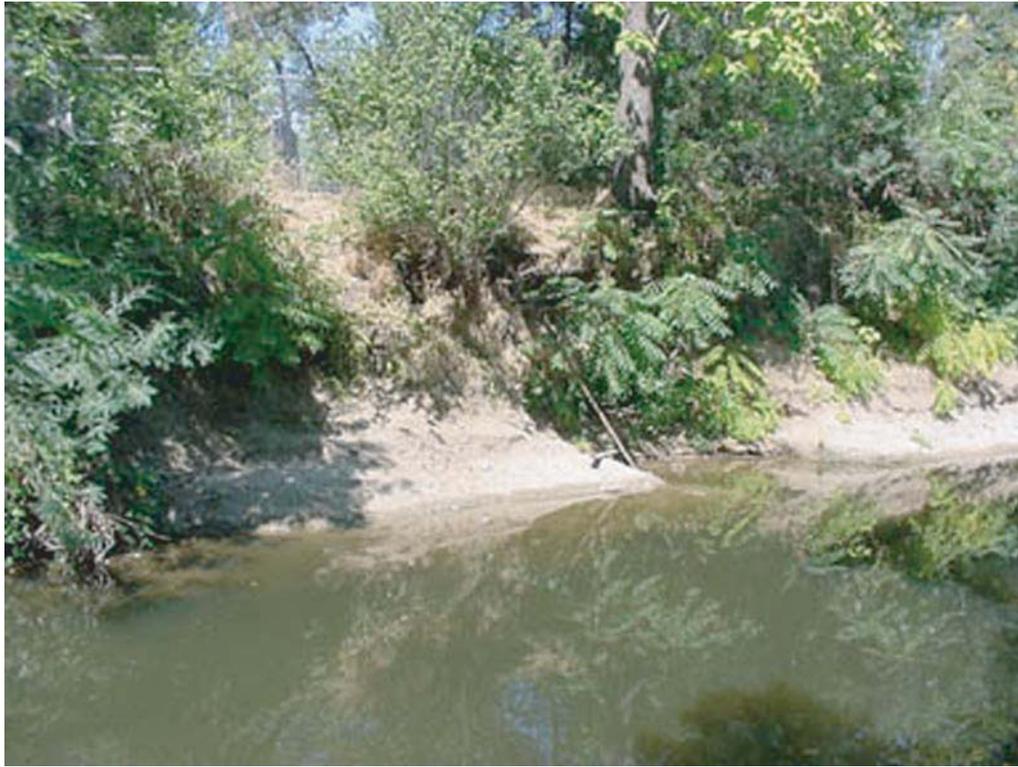
Photo of Site 25L (See Figure 8-E)

Shallow failure occurs when loose bank material at the surface of the stream bank slides and rolls down the bank face (**Figure 9A**). This is the most easily identifiable failure on Dry Creek. Banks can be observed with unconsolidated sand maintaining a slope angle of approximately  $35^\circ$ , the angle of internal friction ( $\Phi$ ) for sand. The sandy hydraulic mining debris chronically fails by the gradual loosening of individual grains that slide parallel to the slope. The erosion of material by water flow at the toe of the stream bank increases the slope angle of the sandy deposit and perpetuates chronic erosion. During large rainstorms or after high creek levels, unvegetated sandy banks may fail at angles as low as  $20^\circ$ , well below the angle of internal friction. This is because the weight of the material on the bank has significantly increased and seepage pressure of the water counteracts the normal stress maintaining stability. Shallow failures can be observed at erosion sites E25 as shown in **Figure 10A**.

**Figure 10a - Shallow Failure**

Channel incision and floodplain encroachment have resulted in an over steepened bank at Site 25L. The unconsolidated sandy hydraulic mining debris on this steep slope continues to erode by slow particle loss i.e. shallow failure

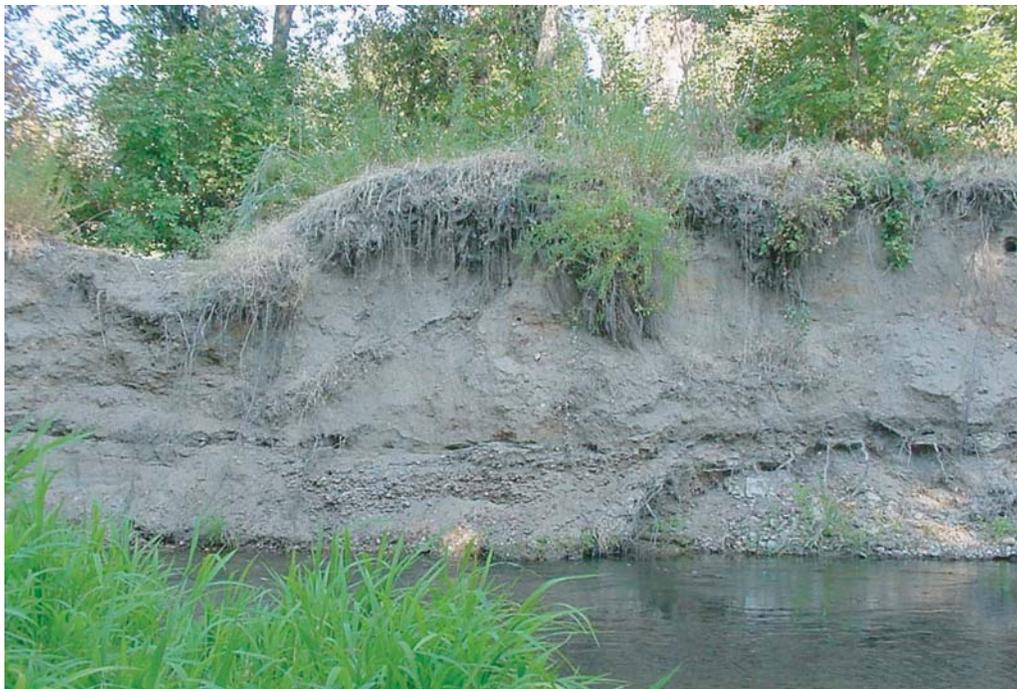
Photo of Site 38L (See Figure 8-D)

**Figure 10b - Slab Failure**

Site 38L is a classic example of toe undercutting of the outer bank at a meander bend in Dry Creek. Undercutting over steepens the unconsolidated bank material and exacerbates both slab and planar failure.

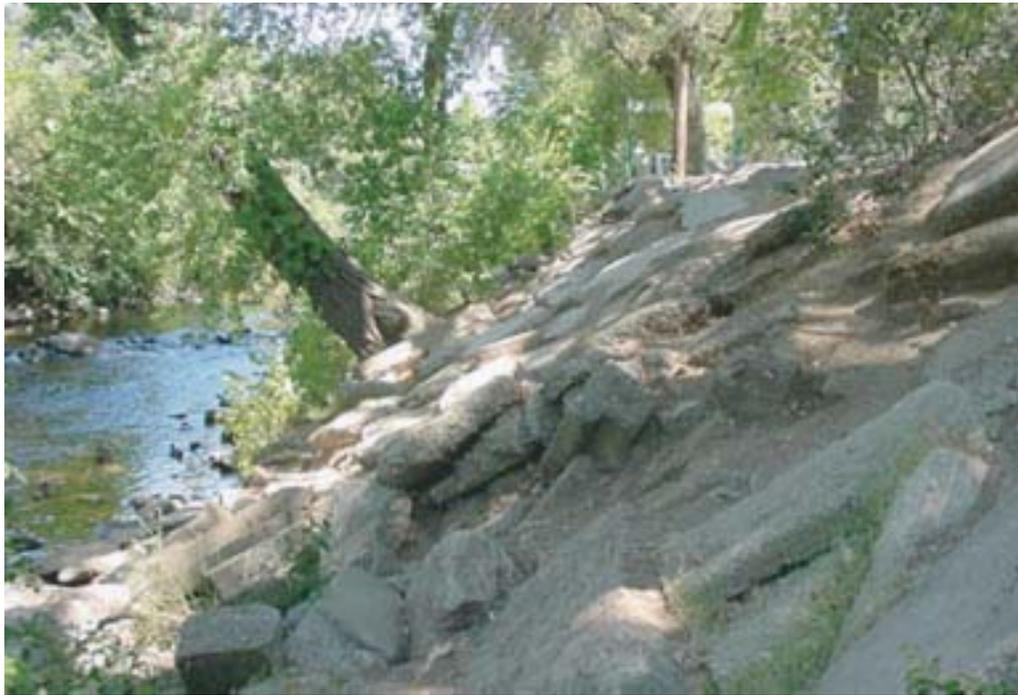
Photo of Site 23L (See Figure 8-E)

**Figure 11a - Bank Protection Failing**

While rip-rap may provide relatively long-term stability for the subject bank failure, the energy focused at armored sites can be dispersed and influence adjacent sites if not carefully designed. In addition, cemented rip-rap does not fulfill the habitat enhancement objectives for overall reach enhancement.

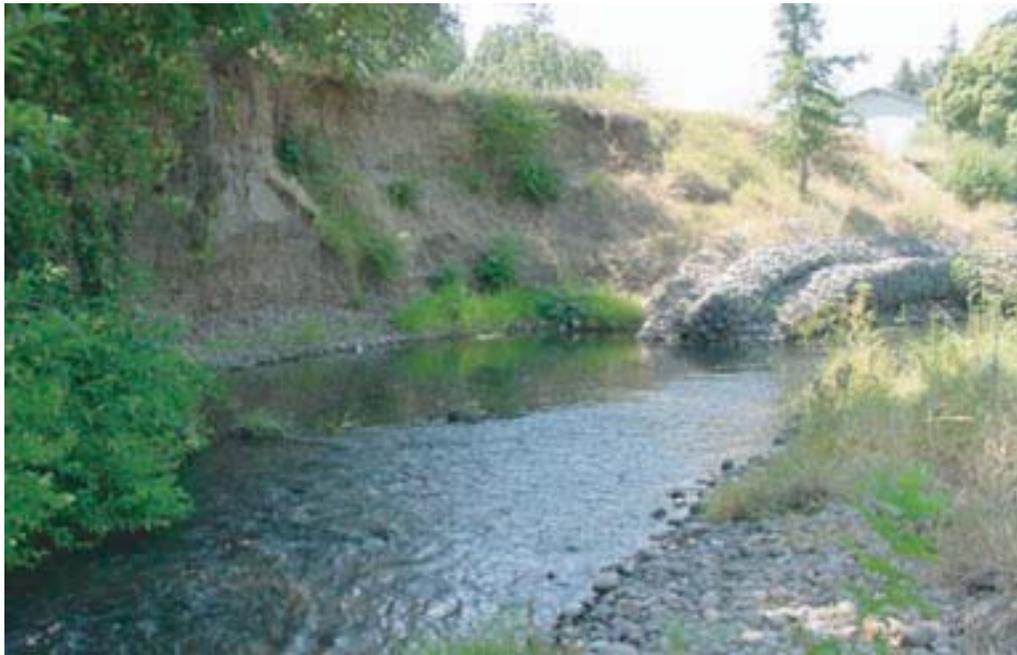
Photo of Site 4L (See Figure 8-G)

**Figure 11b - Bank Protection Failure**

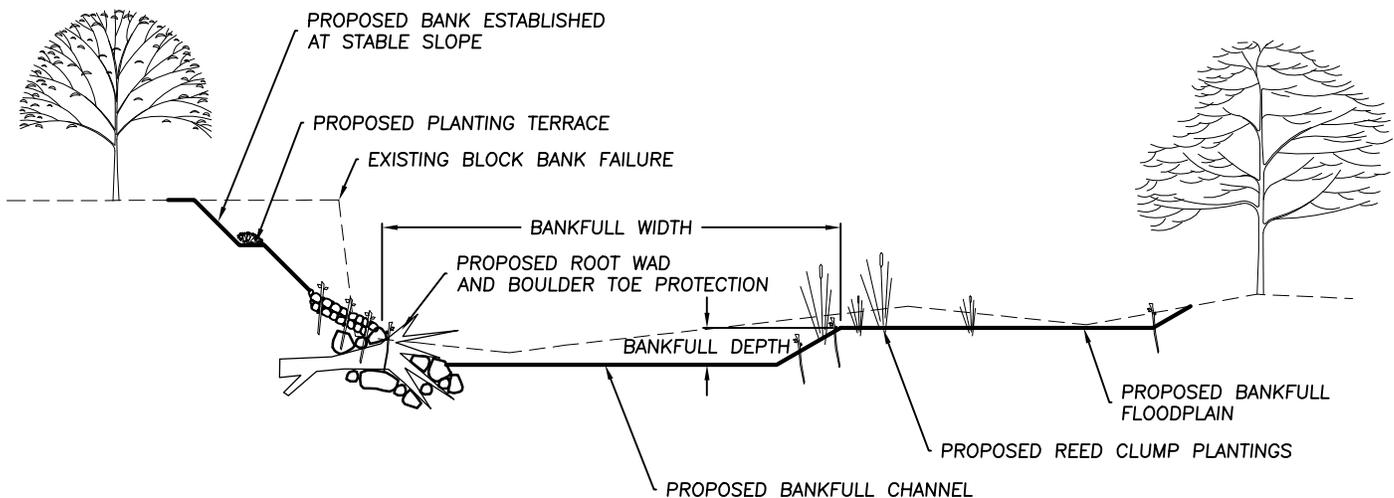
1. SEDIMENT TRANSPORT DISCONTINUITY HAS RESULTED IN EXCESSIVE DEPOSITION AT THIS SECTION.
2. CHANNEL HAS DIVERTED AROUND DEPOSITED BAR AND HAS UNDERCUT THE LEFT BANK.
3. UNDEVELOPED SPACE IS AVAILABLE AT THE TOP OF EACH BANK, ALLOWING FOR GEOMORPHIC RECONFIGURATION (REFER TO FIG. 15 FOR CONCEPTUAL PLAN AND PROFILE).

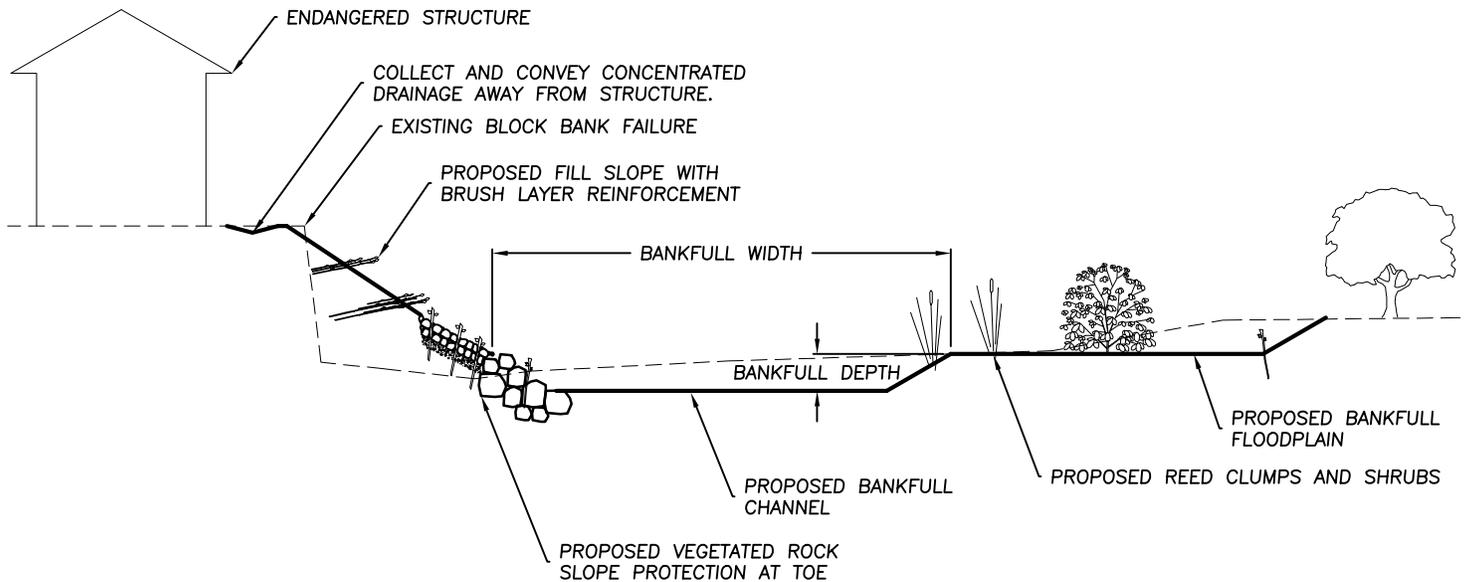
1. UPSTREAM BANK HARDENING HAS DEFLECTED FLOW INTO THE LEFT BANK.
2. EXISTING DEVELOPMENT CREATES CONDITIONS WHERE SPACE IS NOT AVAILABLE AT THE TOP OF THE LEFT BANK.

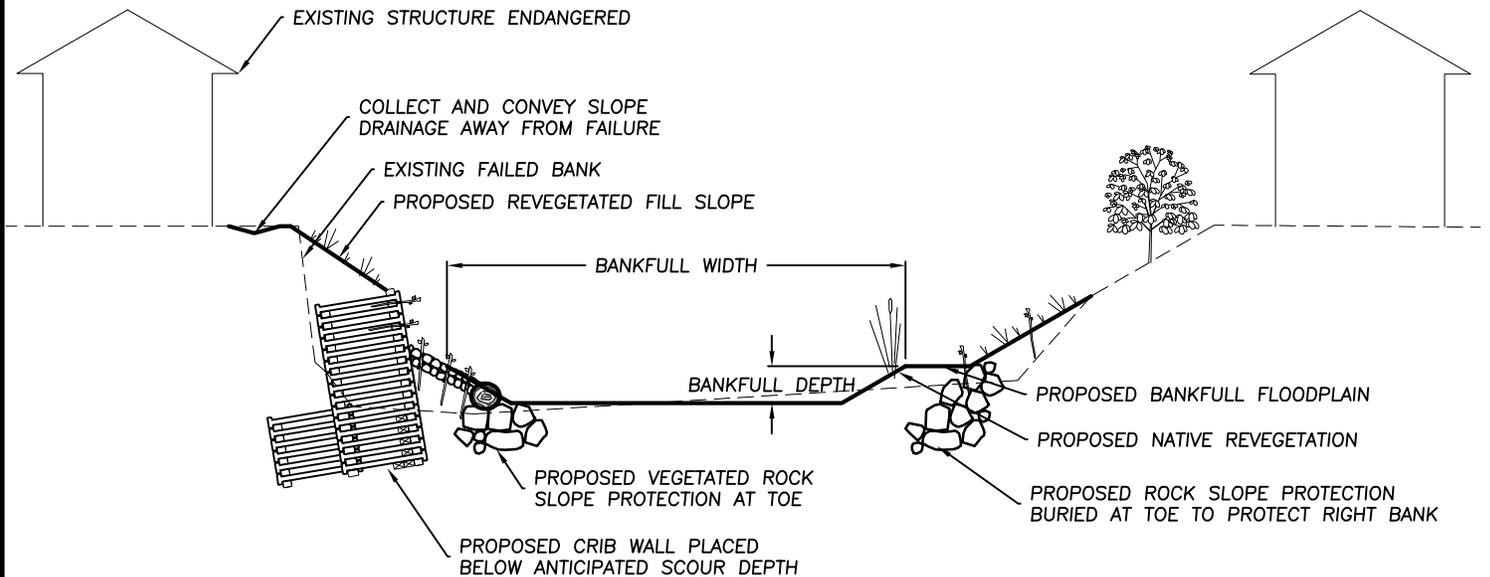
1. CHANNEL IS CONFINED AND INCISED.
2. UNDERCUTTING OF BANK DUE TO CHANNEL INCISION HAS CAUSED SLOPE FAILURE.
3. FUTURE SLOPE FAILURE WILL THREATEN STRUCTURES.

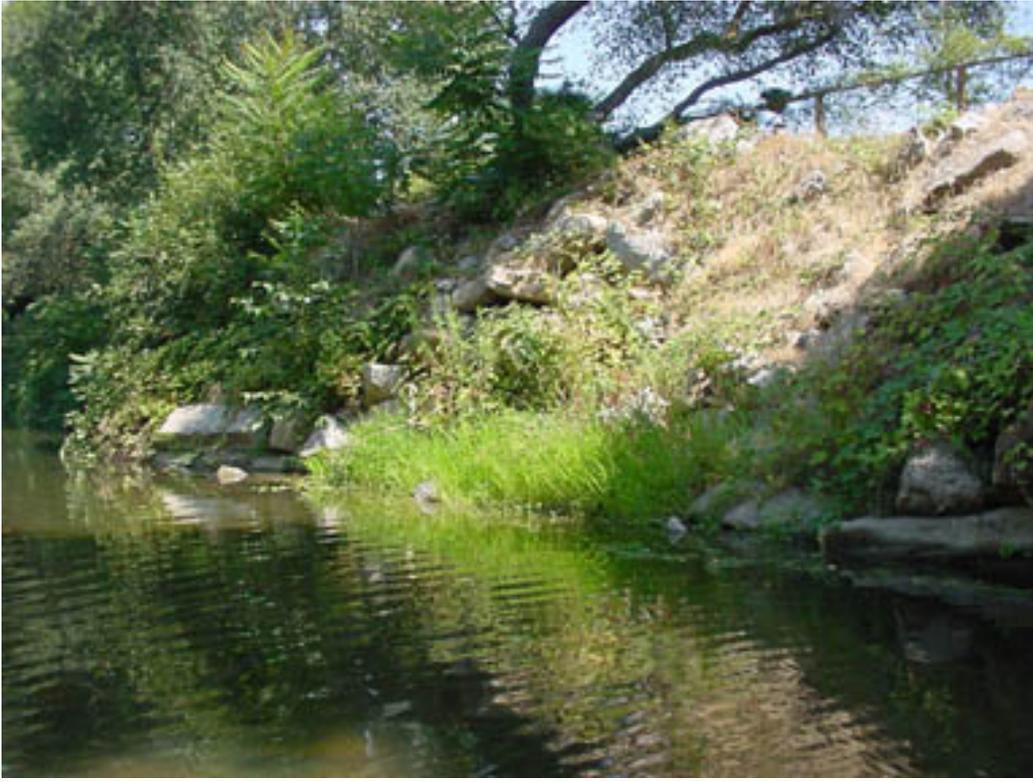
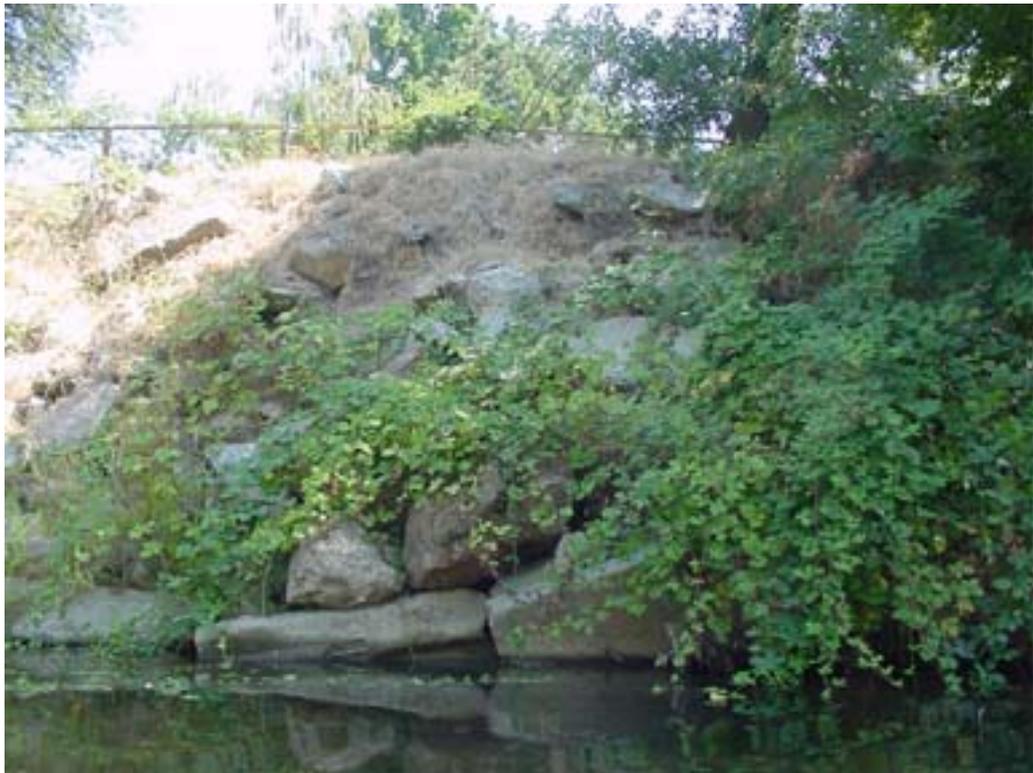
Site 2L

- Located on inside of gradual left-hand turn
- Large concrete rubble at toe with rsp placed above
- Appears stable, but lacks mature vegetation or adequate habitat value
- Majority of the voids of concrete at toe contain no fines, and will not support revegetation

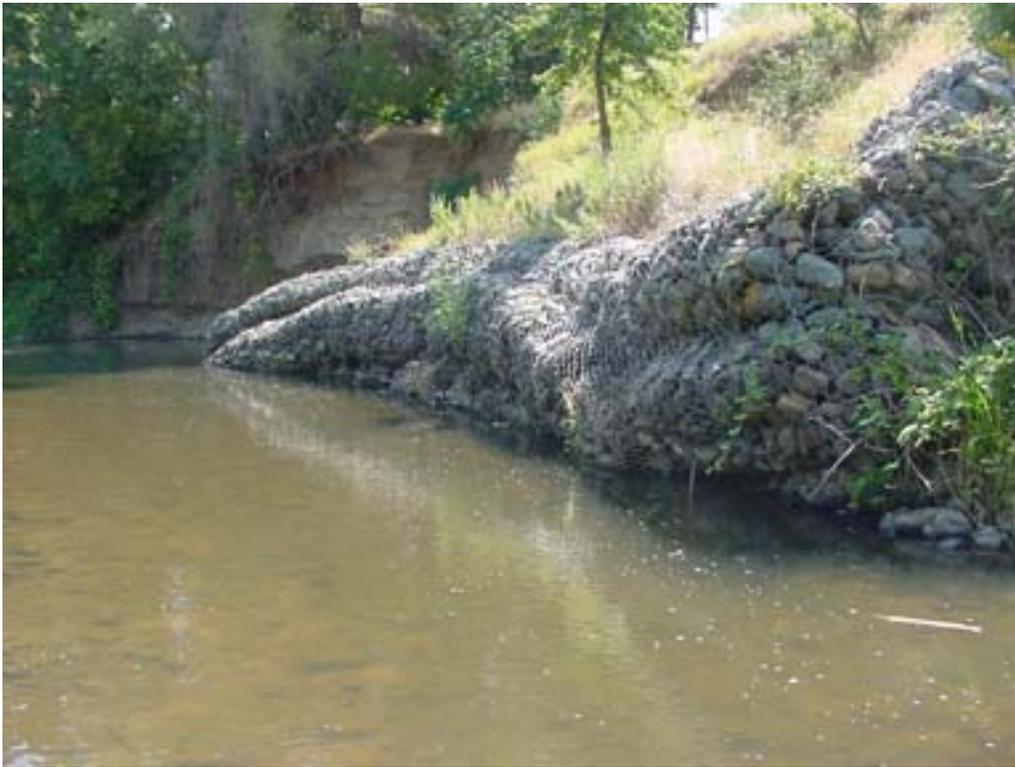
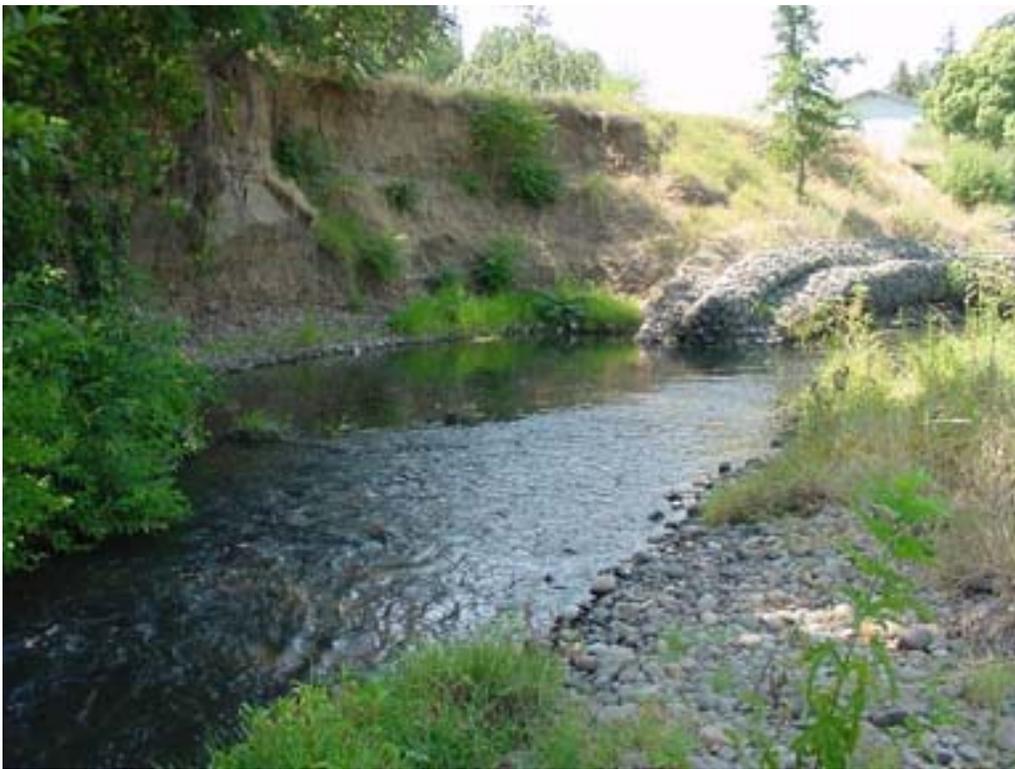
Site 4L

- Located on outside of right-hand turn
- Bank is steep, composed primarily of sandy material
- Channel section appears to have sufficient width, with good bar formation on opposite bank
- Existing gabion wall appears to have failed from flanking and subsequent eddy formation
- Wall was constructed from rounded river-run cobble. Angular infill material would have provided greater stability

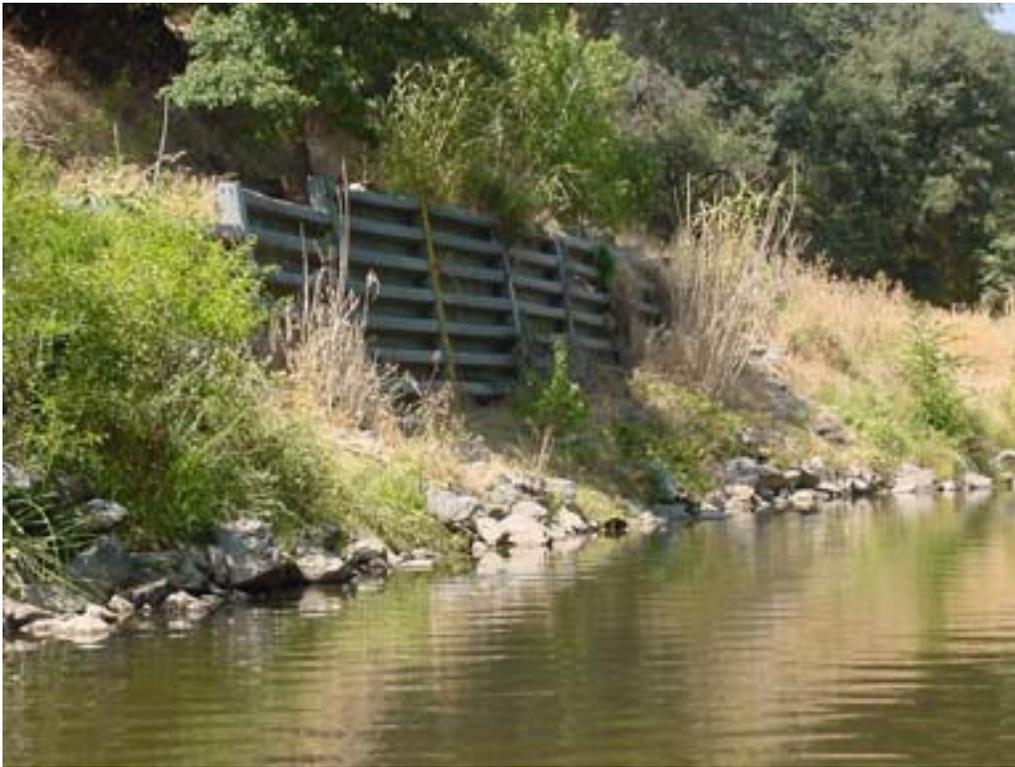
**Site 6R**

- Located on outside of left-hand turn
- Metal crib wall is protecting road alignment at top of slope
- Some signs of stress in wall, where headers have deformed under load
- Rsp at toe of crib wall appears relatively stable and to be providing some opportunity for revegetation
- Lacks mature riparian tree cover for shade

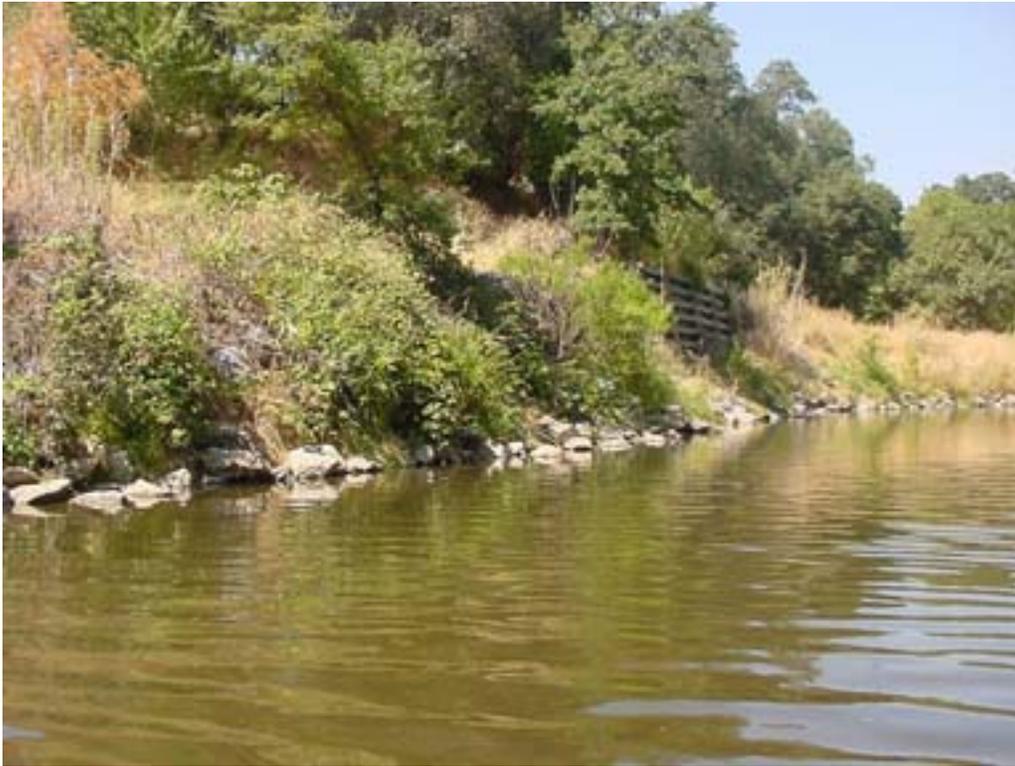
**Site 7R**

- Located on outside of left-hand turn
- Gabions form downstream transition from metal crib wall (site 6R)
- Appears to be stable and revegetating
- Lacks mature riparian tree cover for shade

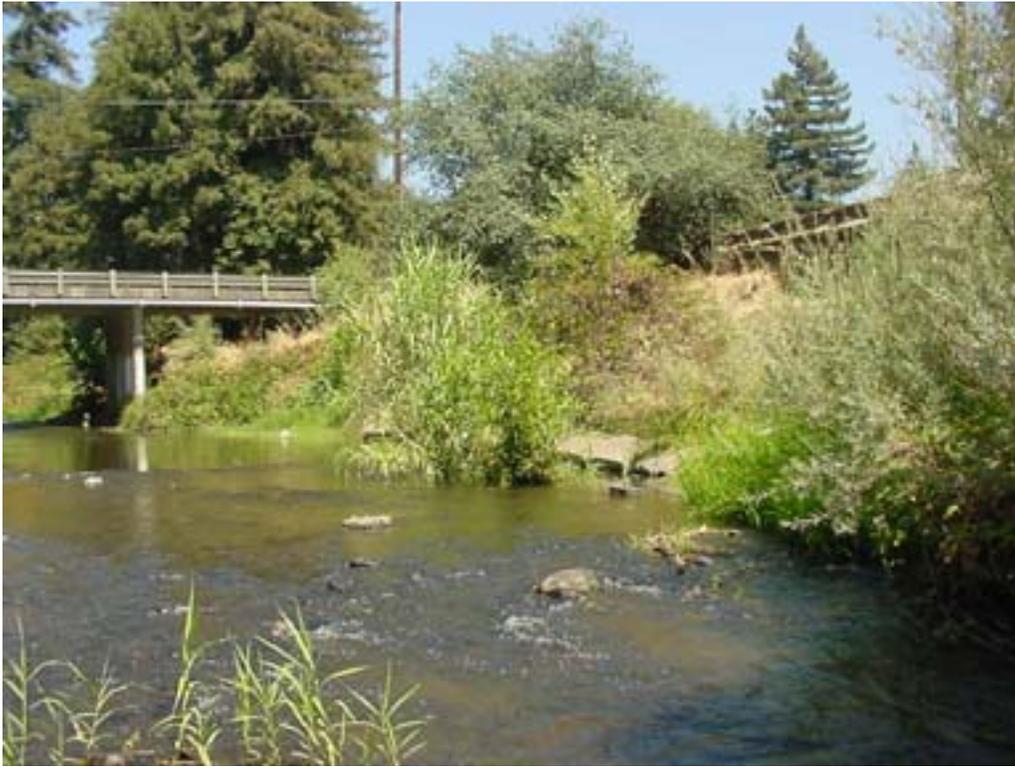
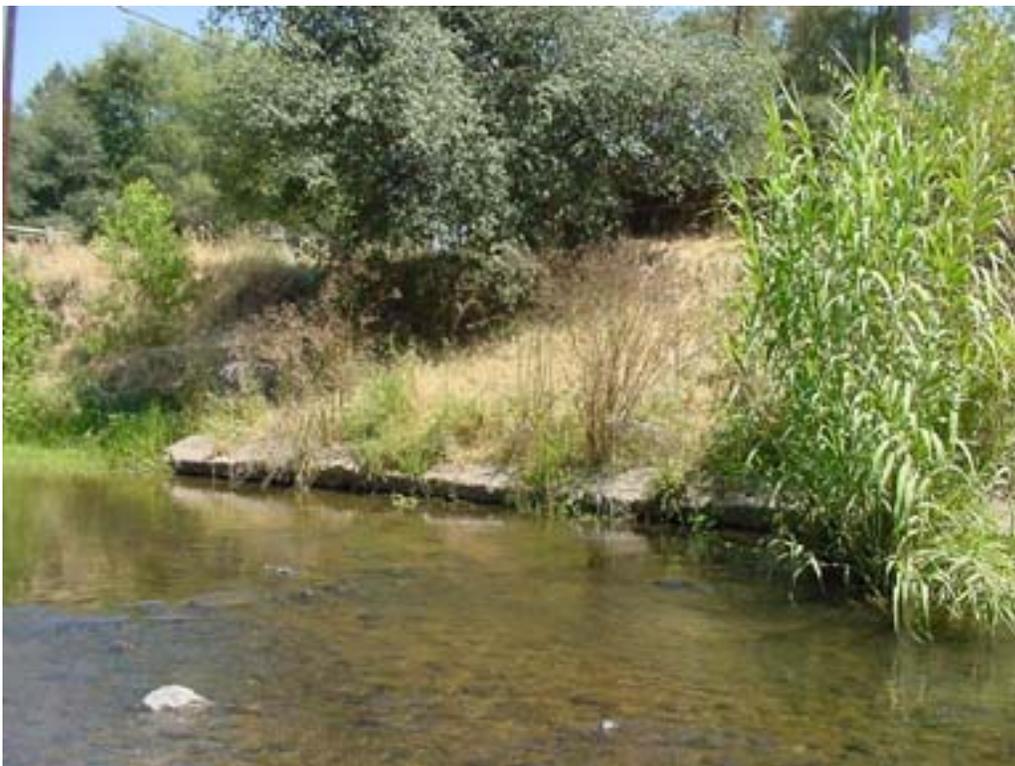
Site 9L

- Located on straight reach just downstream of Folsom bridge
- Numerous concrete structures located within bank
- Erosion present at upper slope
- Exotic invasive species present
- Toe appears to be stable and revegetating, but lacks mature riparian tree cover for shade

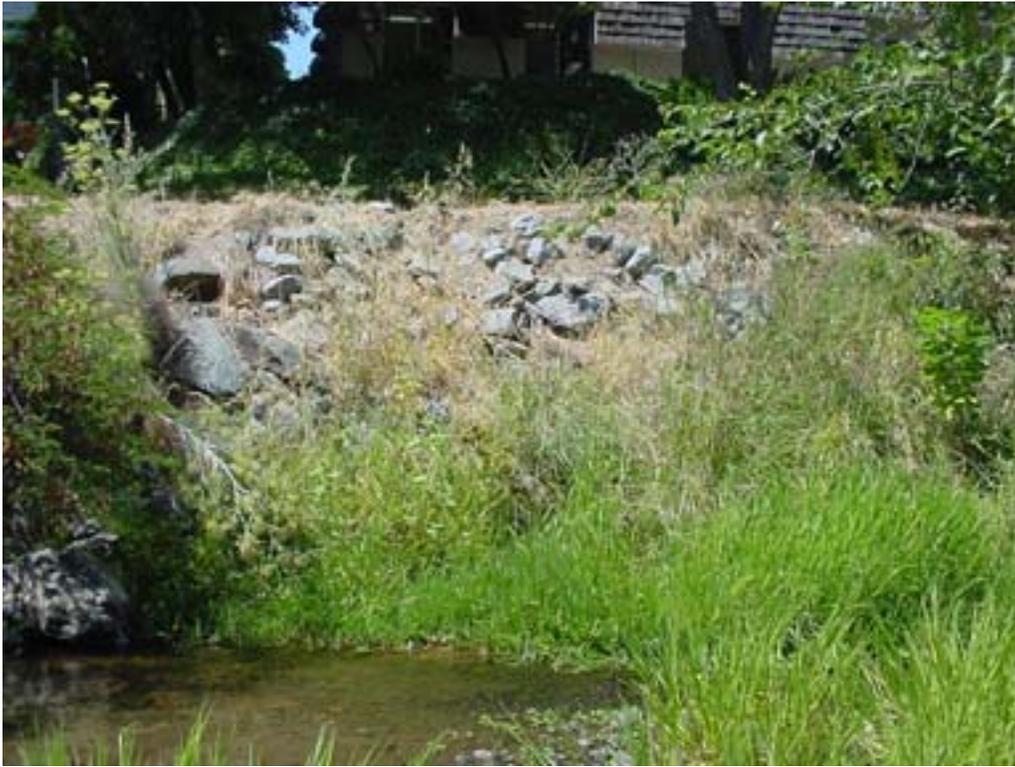
**Site 10R**

- Located on straight section within confined channel reach
- Toe is stable and well vegetated
- Existing road at top of bank limits planting area
- Lacks mature riparian tree cover

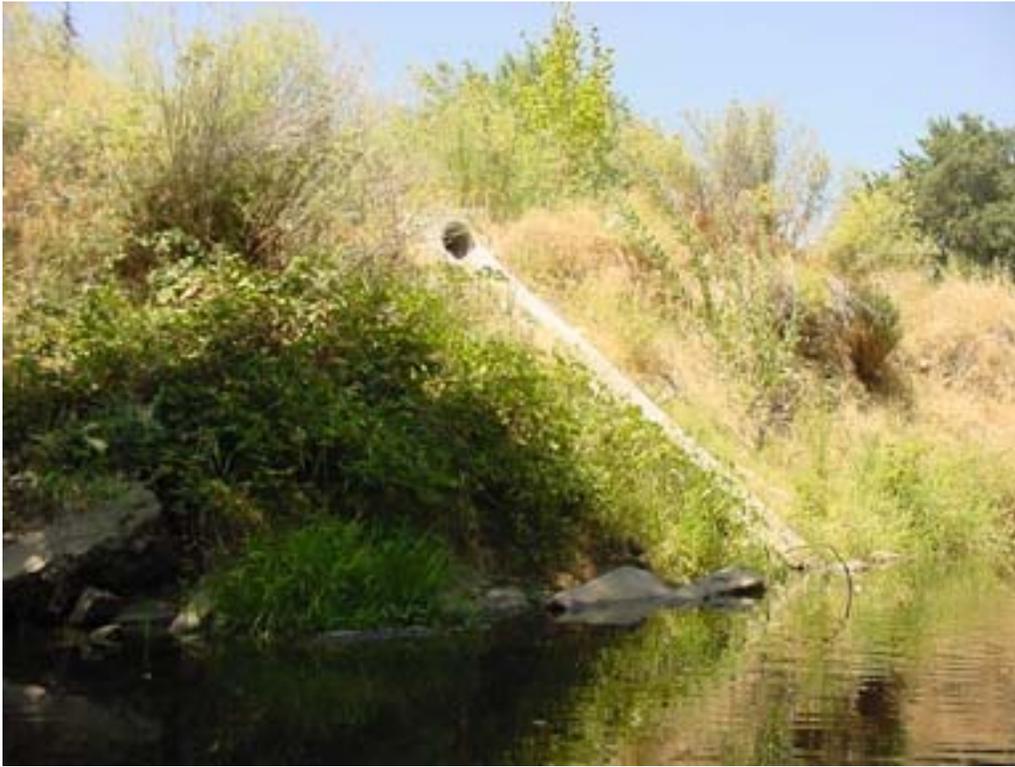
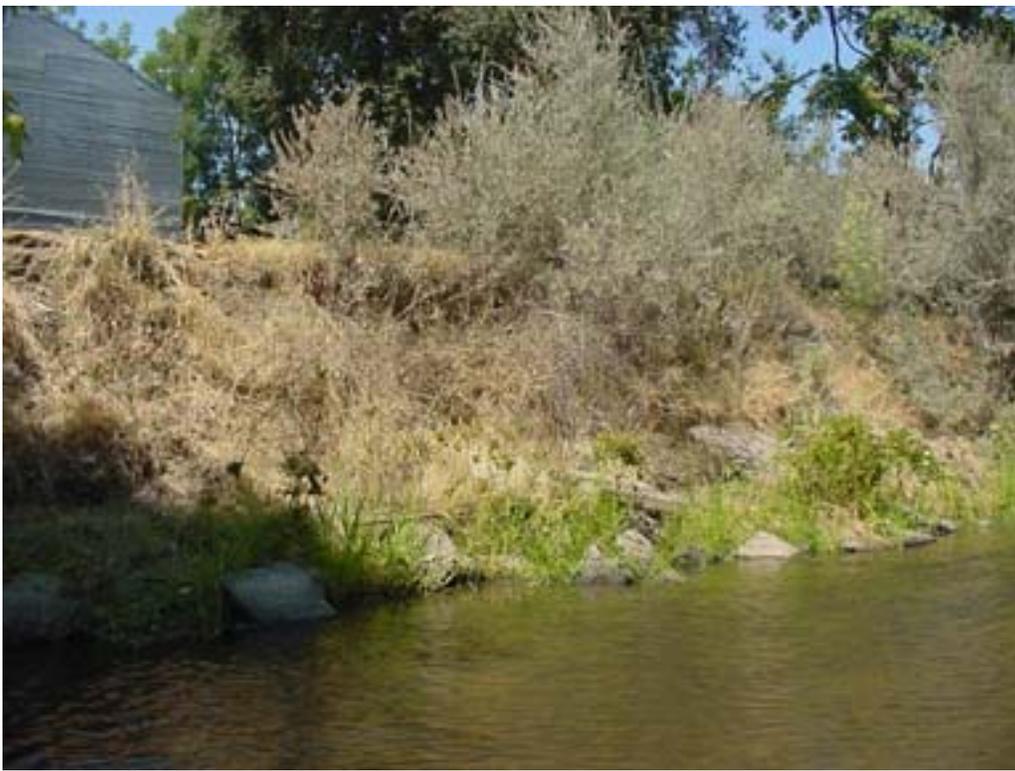
Site 10R-A

- Located on straight reach just downstream of Folsom bridge
- Toe appears stable, but bank is steep and failing in some locations
- Lack of mature riparian trees
-

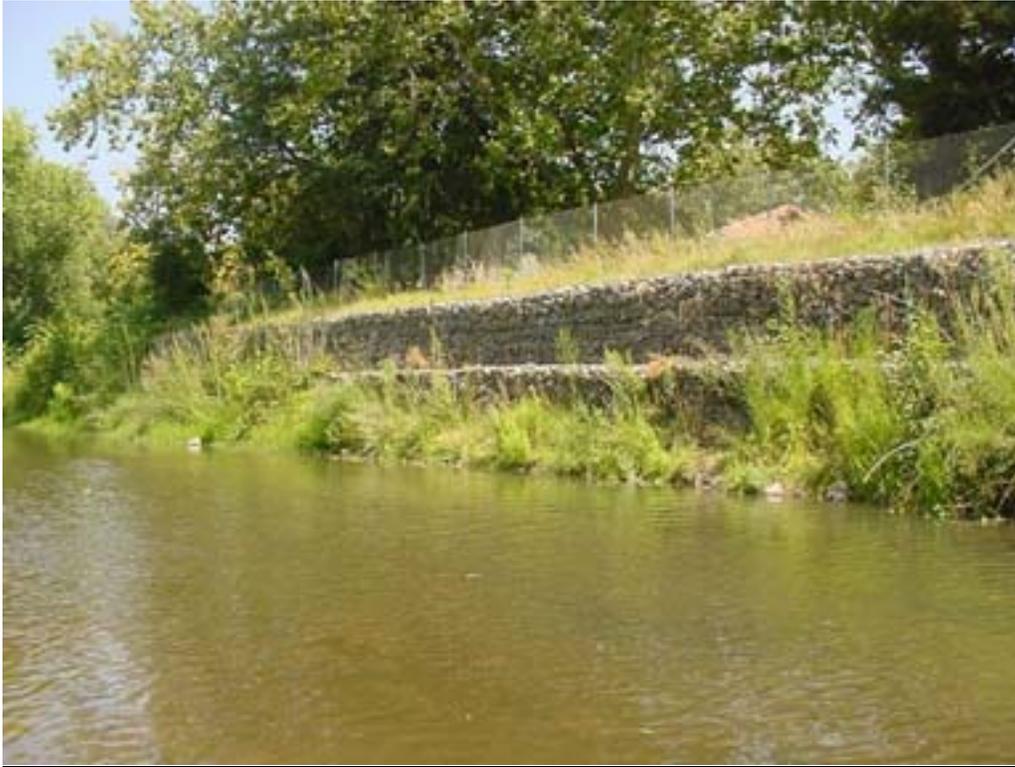
## Site 12L

- Located on straight reach
- Gabions appear stable, with vegetation at toe
- Lack of mature riparian trees or channel complexity

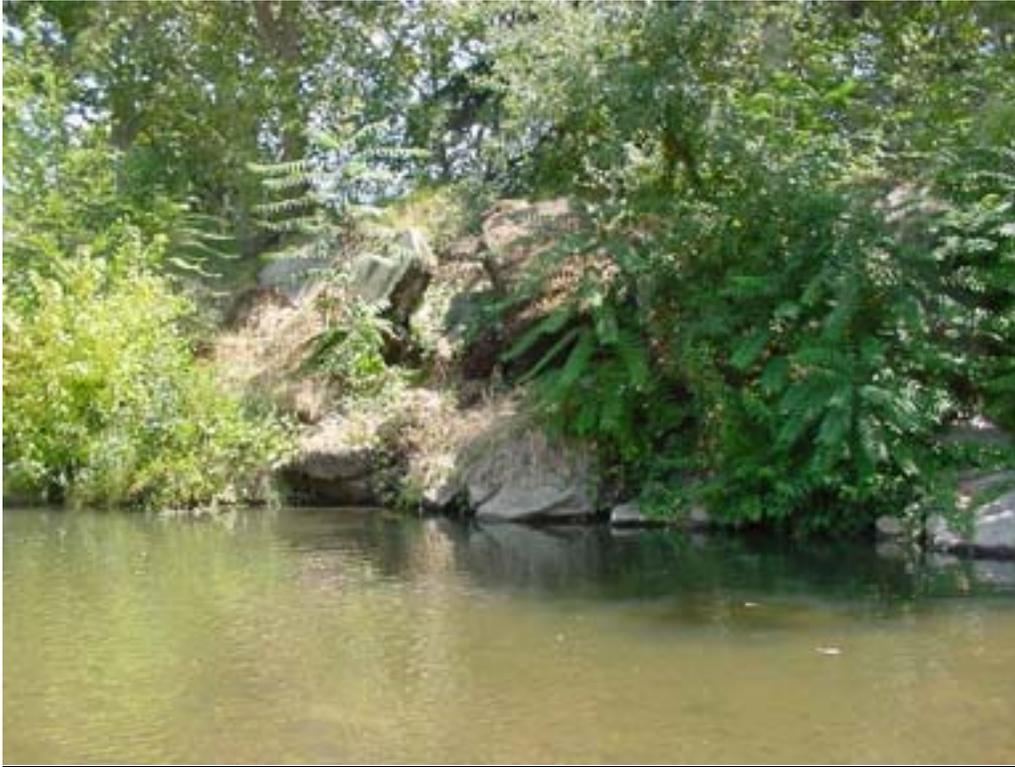
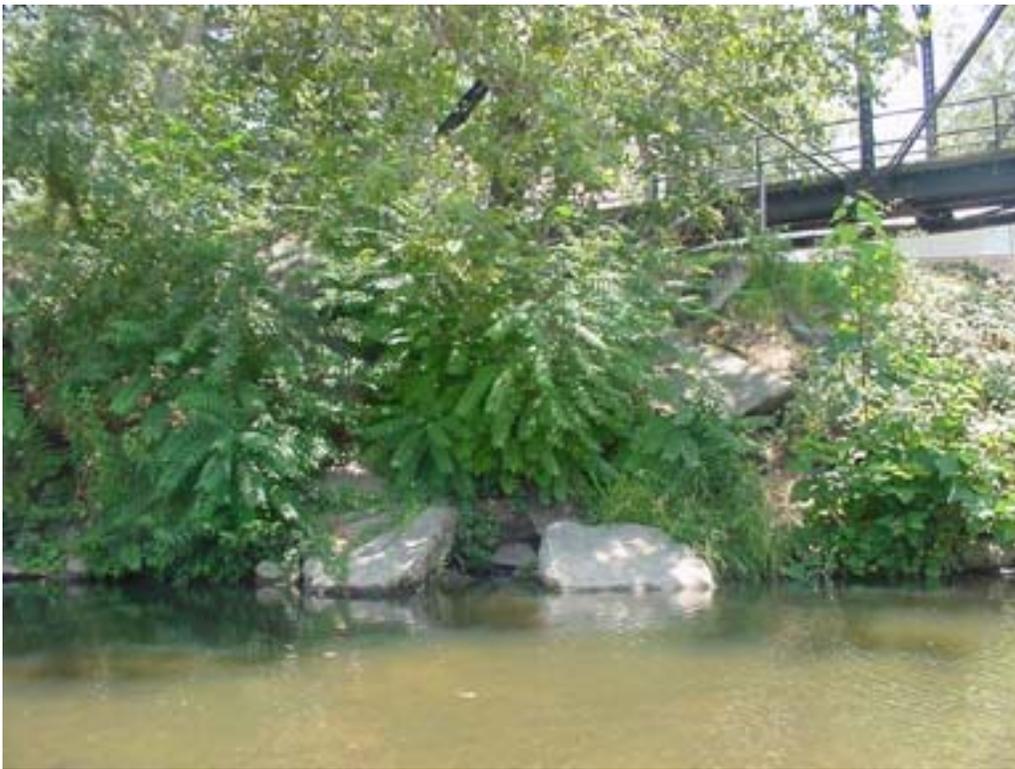
Site 13L

- Located on straight reach
- Large concrete rip rap has stabilized slope
- Some trees have been successfully established
- Voids in rip rap contain sufficient fines for vegetation recruitment

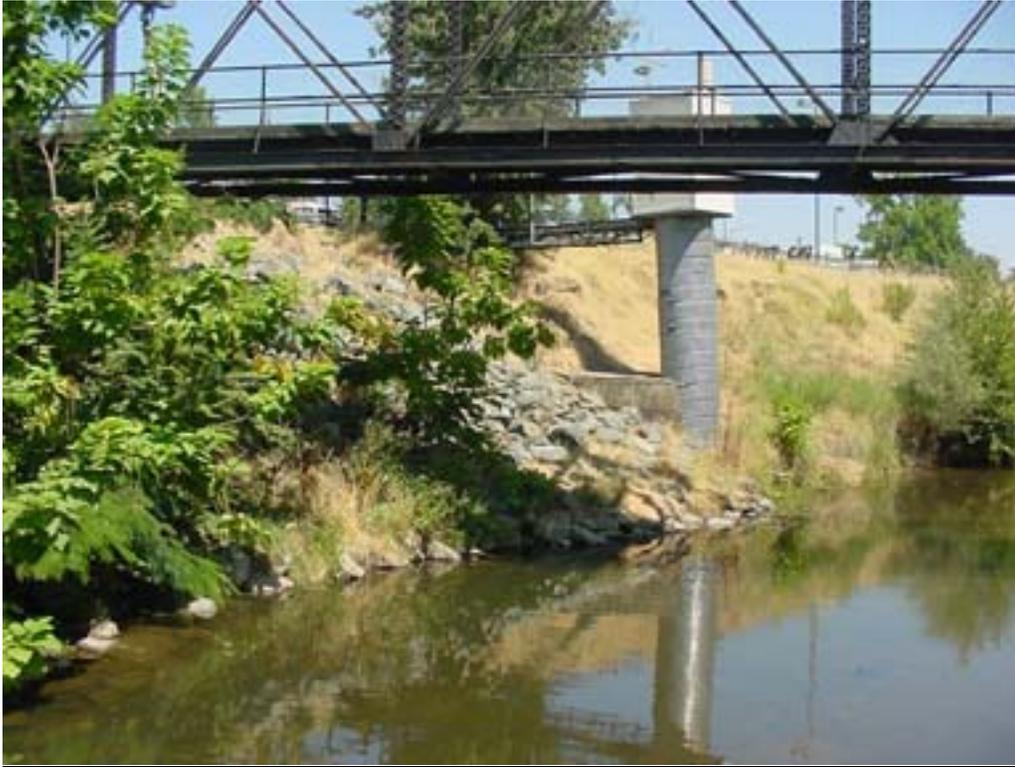
## Site 14R

- Located on outside of gentle left-hand turn
- Rsp has stabilized the slope
- No vegetation has been established
- Lack of mature riparian trees or channel complexity

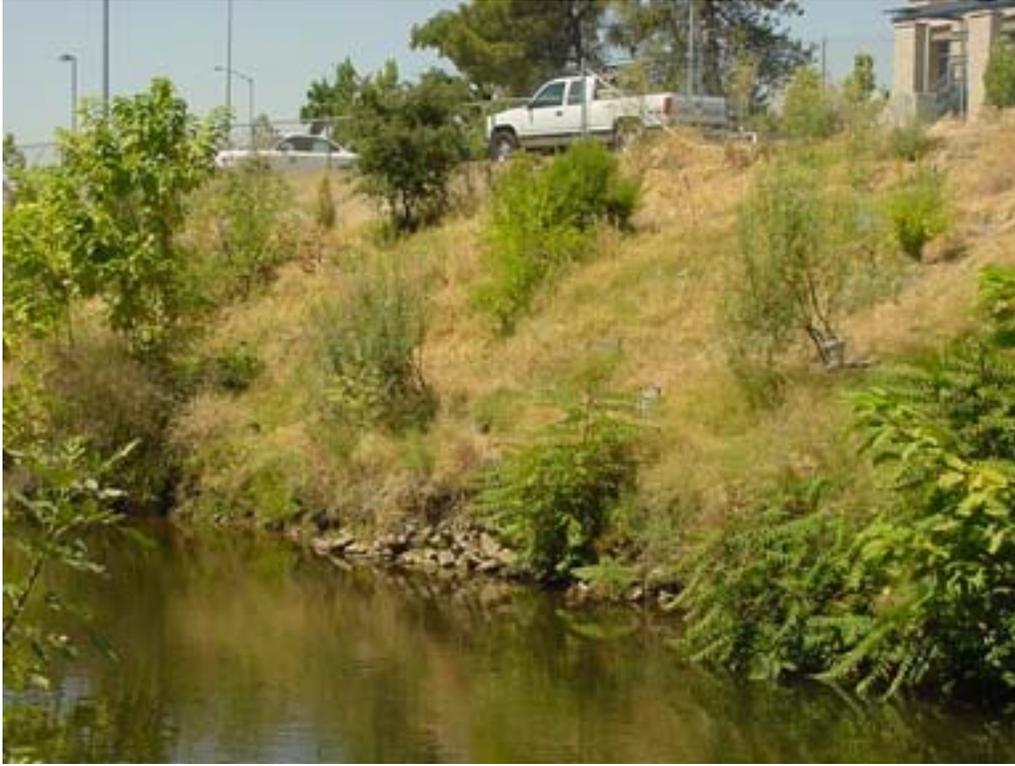
**Site 14R-A**

- Small rsp at toe of well-revegetated slope
- Appears stable

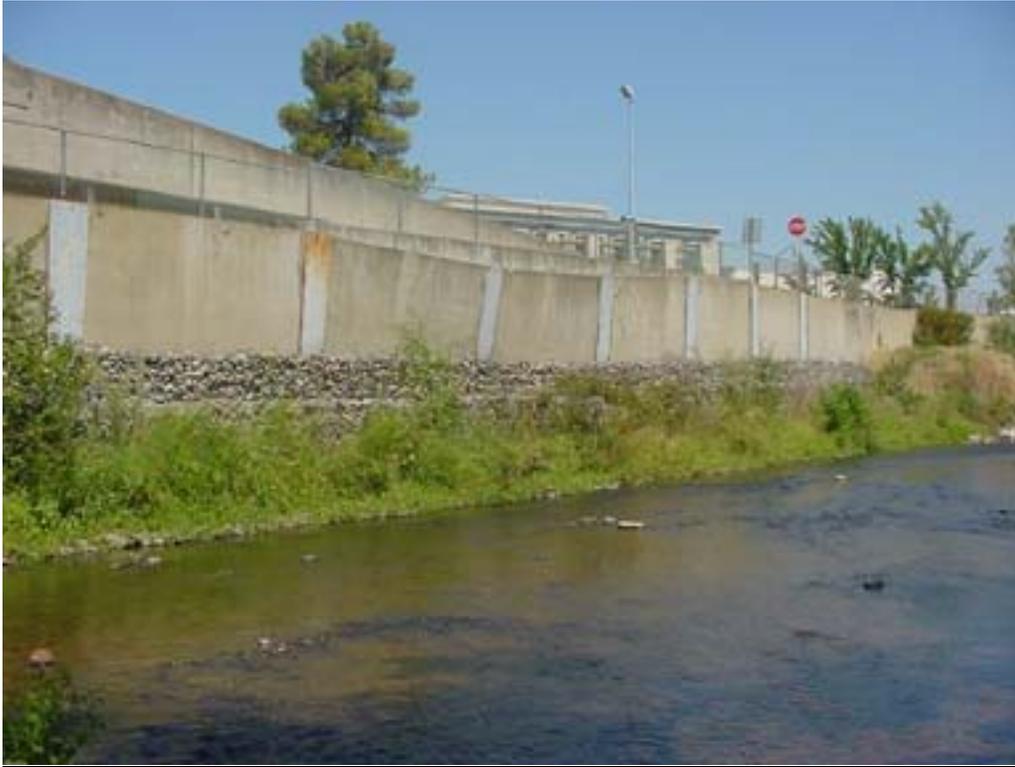
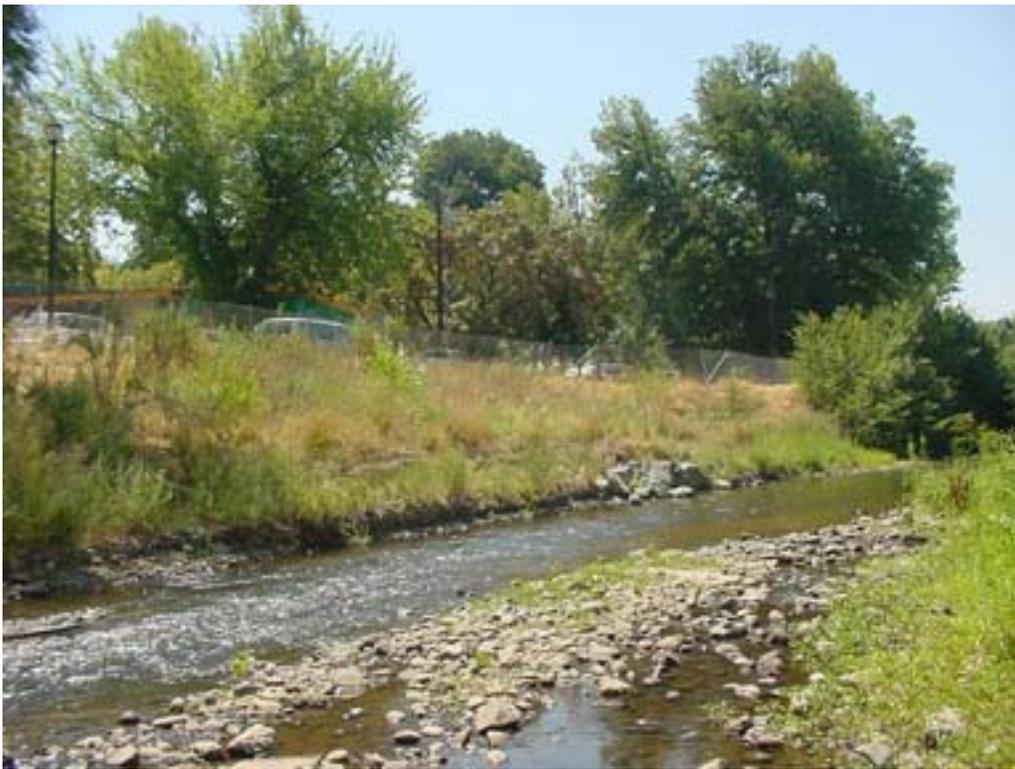
Site 16R

- Gabion wall at toe of slope with concrete wall located above
- Concrete wall appears to be failing and may require eventual replacement
- Gabion wall appears stable, with some vegetation established at toe
- Lack of mature riparian trees or channel complexity
- Channel section appears to have sufficient width
