# Dry Creek Bank Erosion Management Plan

Roseville, California

**July 14, 2003**

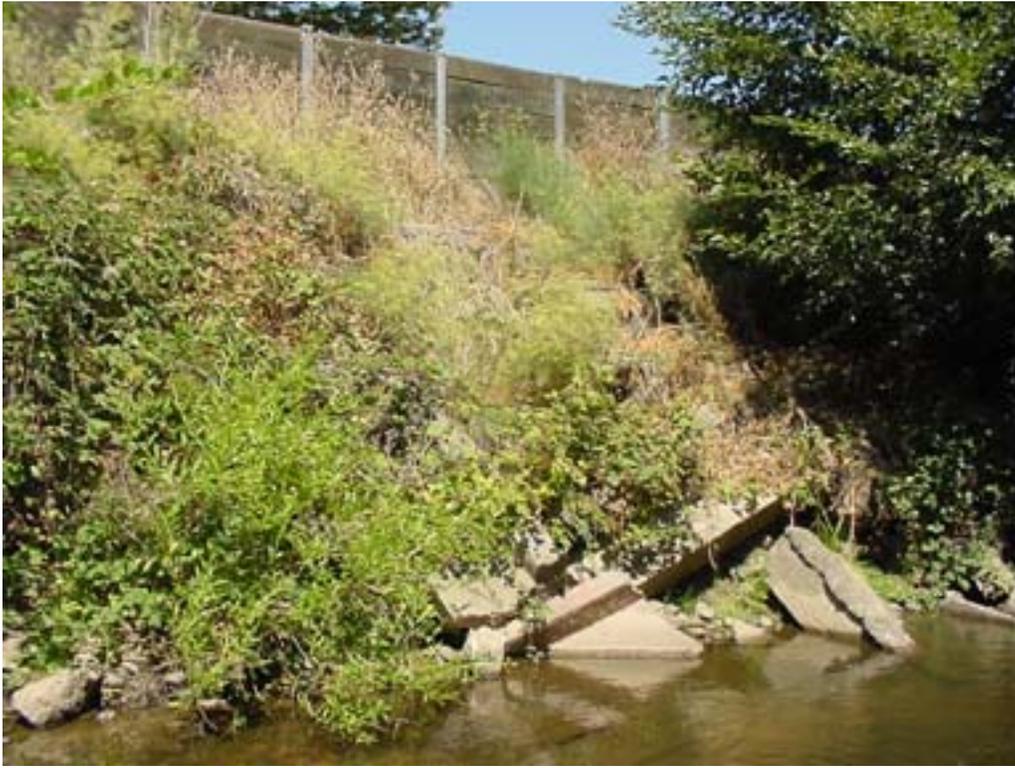
## Sites 17R & 18R

- Large concrete rip rap (18R) at toe of slope with soldier-pile wood wall (17R) at top
- Located at pool below steep riffle section
- Mature tree at toe provides shade for pool
- Rip rap provides cover and stability at outer edge of pool

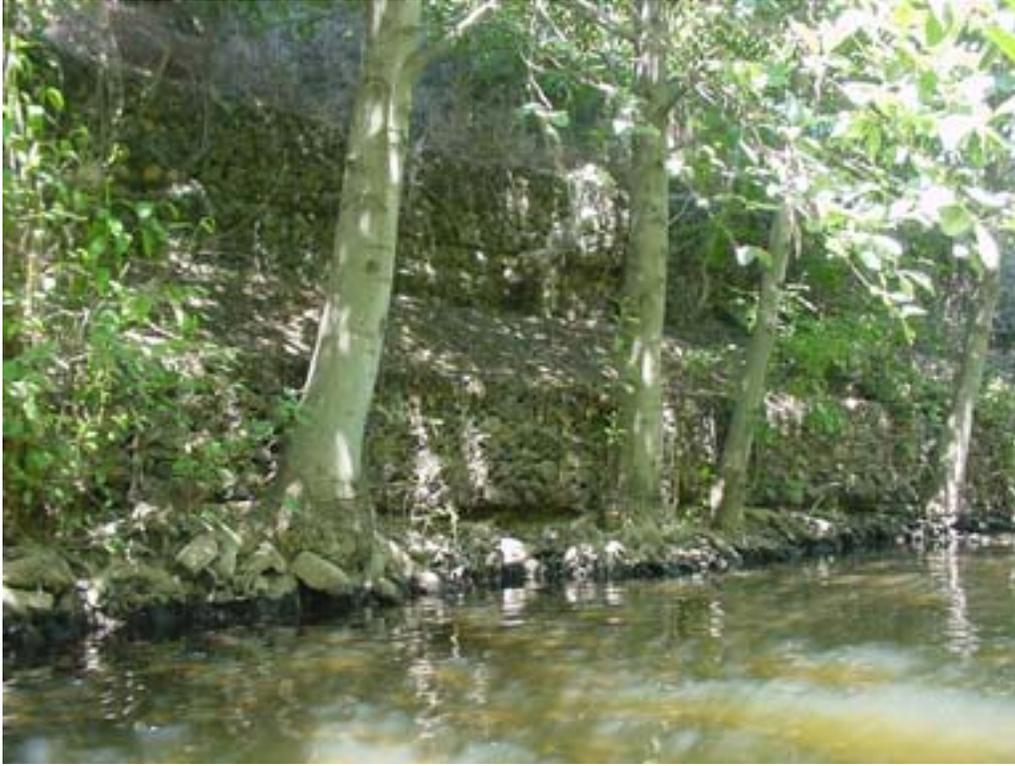
## Site 19R

- Multi-level gabion wall with mature alders lining the toe
- Alders appear to be stabilizing the toe against further scour
- Gabions appear stable
- Shade and cover under trees

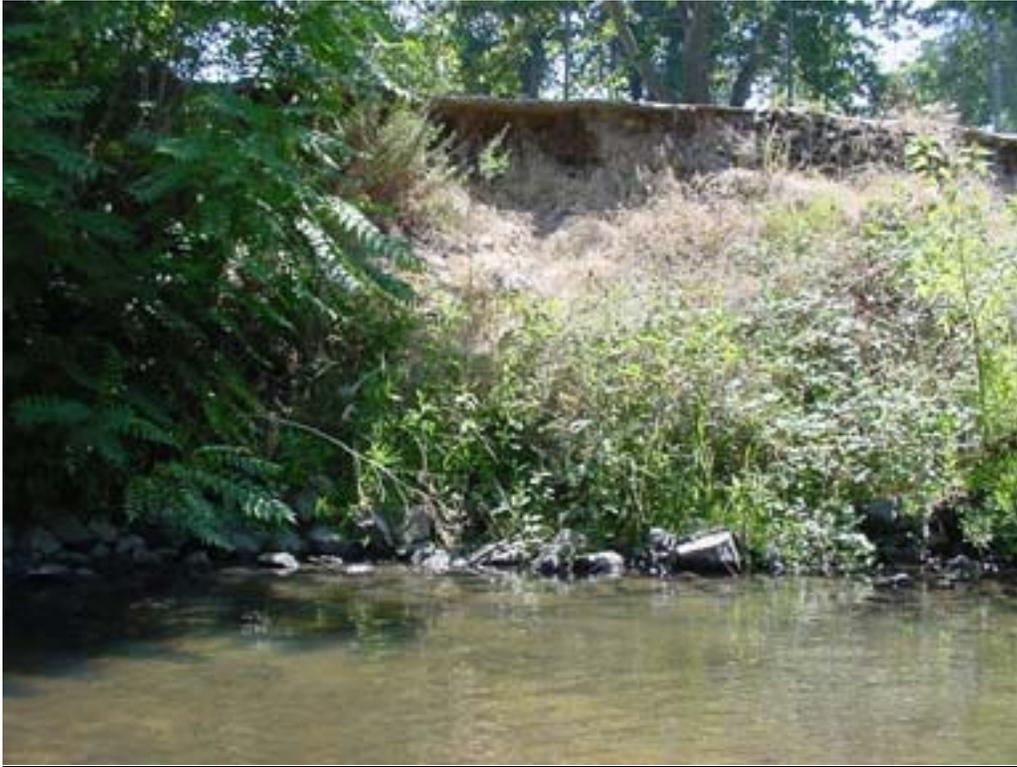
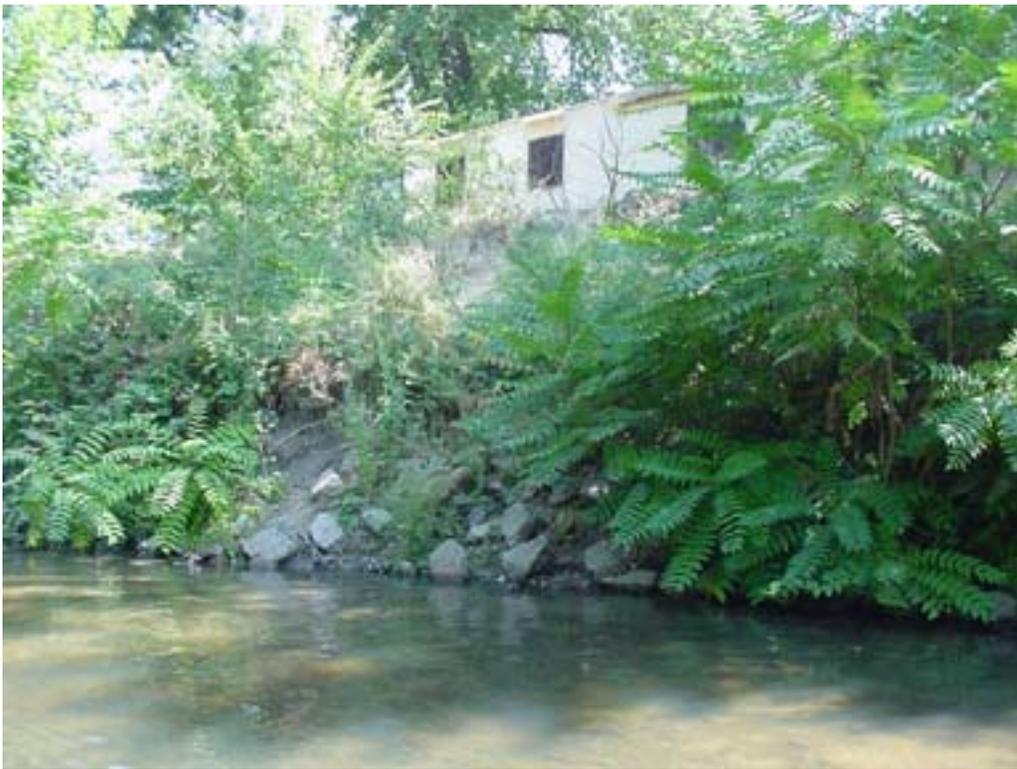
Site 20L

- Small pieces of rsp and rip rap line toe
- Upper bank is eroded, with asphalt undermined
- Vegetation established near toe, where bank appears stable
