# Dry Creek Bank Erosion Management Plan

Roseville, California

**July 14, 2003**

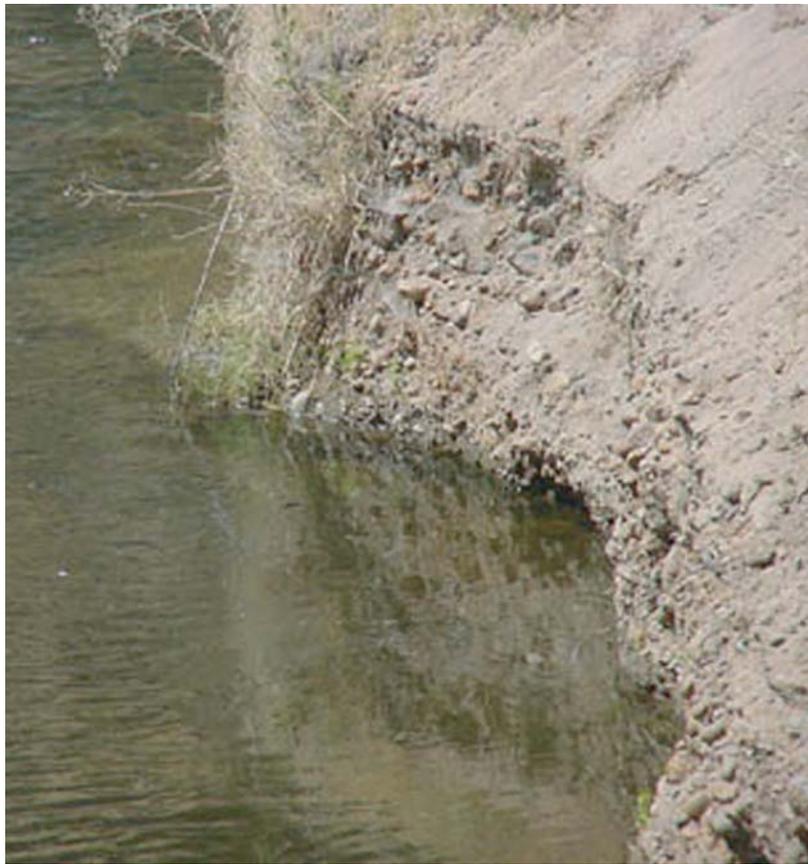
Photo of Site 29R looking downstream

**Figure 6 - Composite Failure**

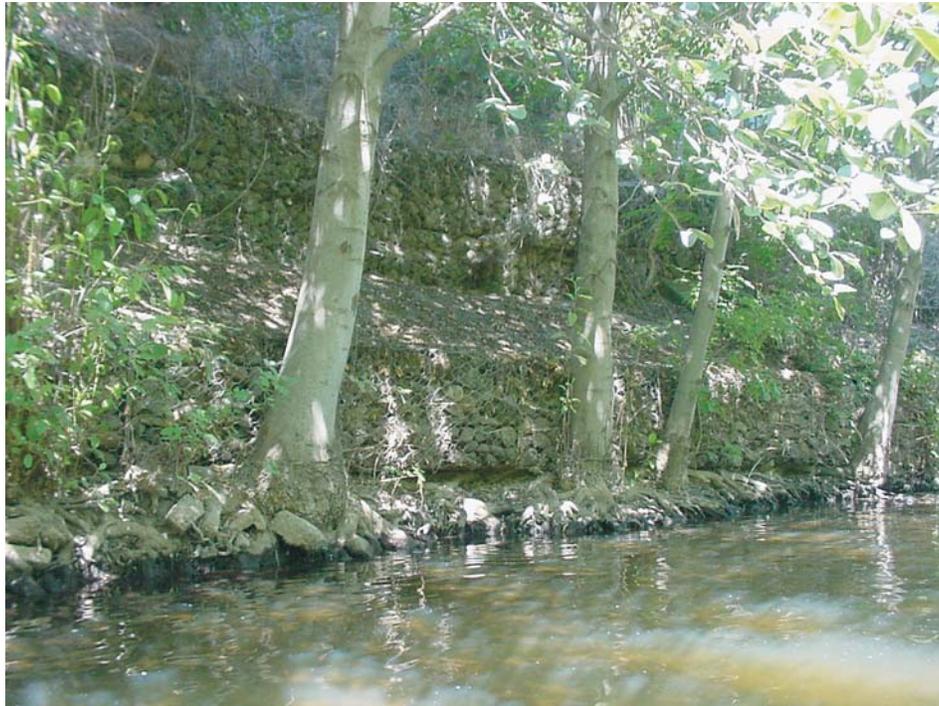
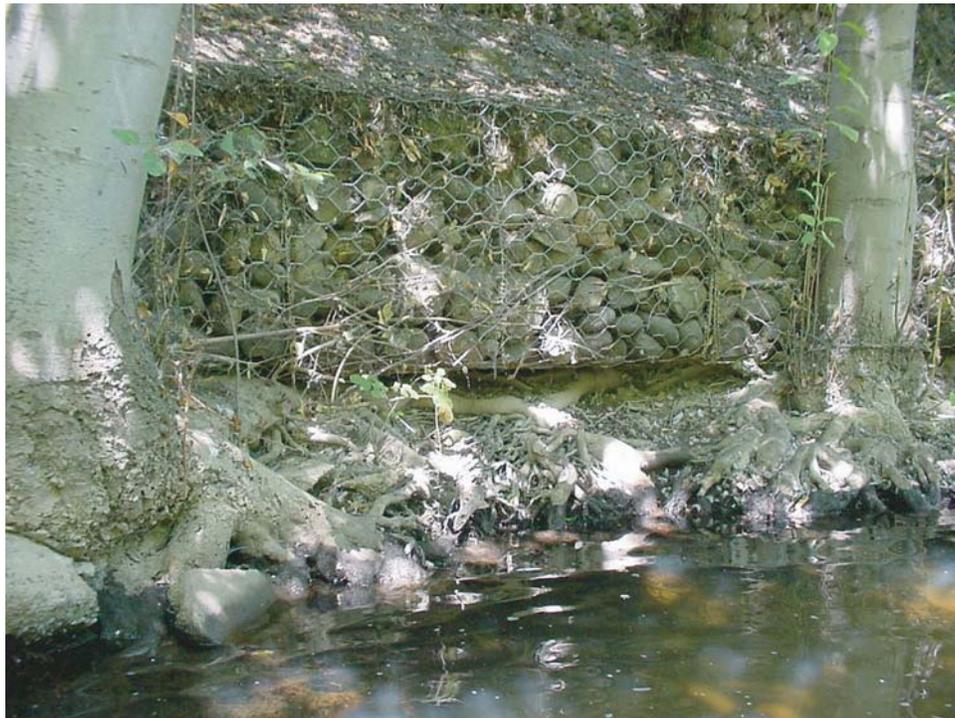
**Figure 12 - Alders Supporting Gabions**

The above photos clearly show the ability of roots to secure soil against scour, stabilizing the toe of the bank.

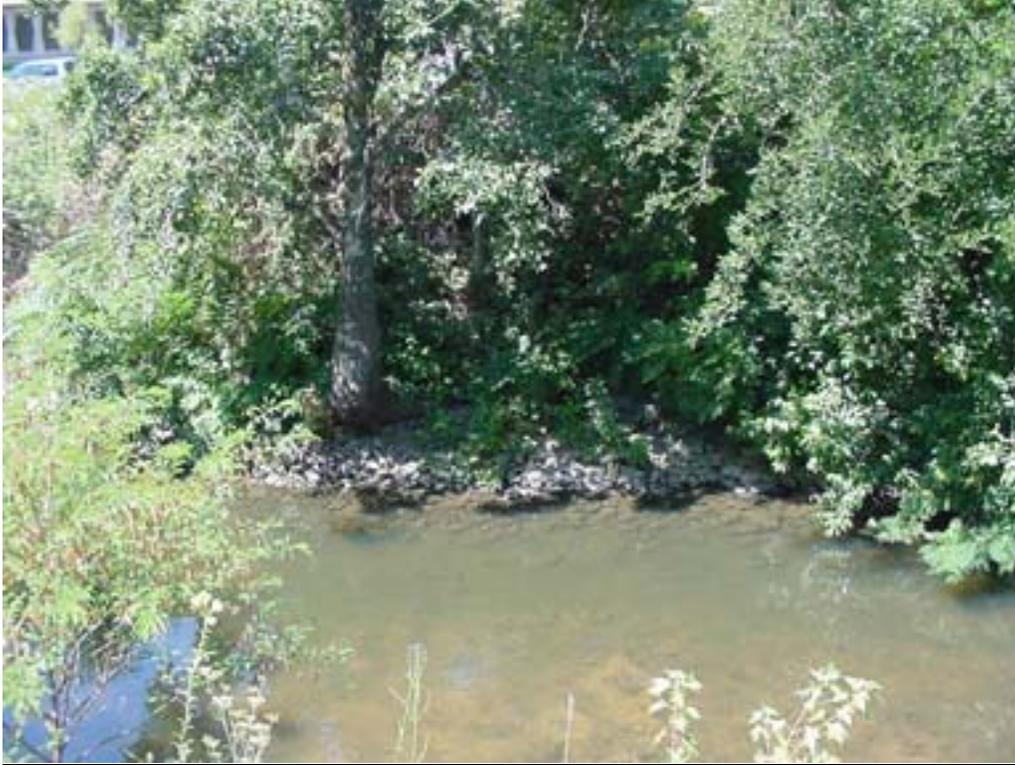
**Site 21R**

- Small pieces of rip rap line toe
- Appears stable, though section is narrow
- Good vegetation established

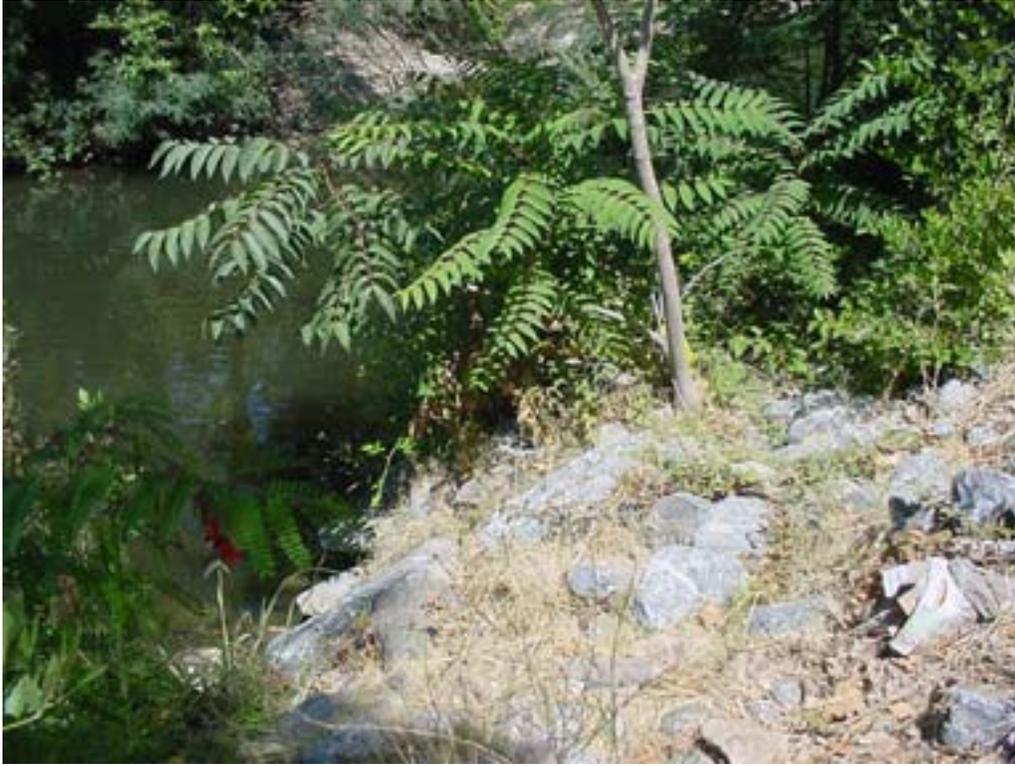
**Site 22L**

- Located within straight, narrow, and steep reach
- Mid-sized rsp with successful revegetation
- Steep slope, but appears stable
- Great example of potential for revegetation of rsp

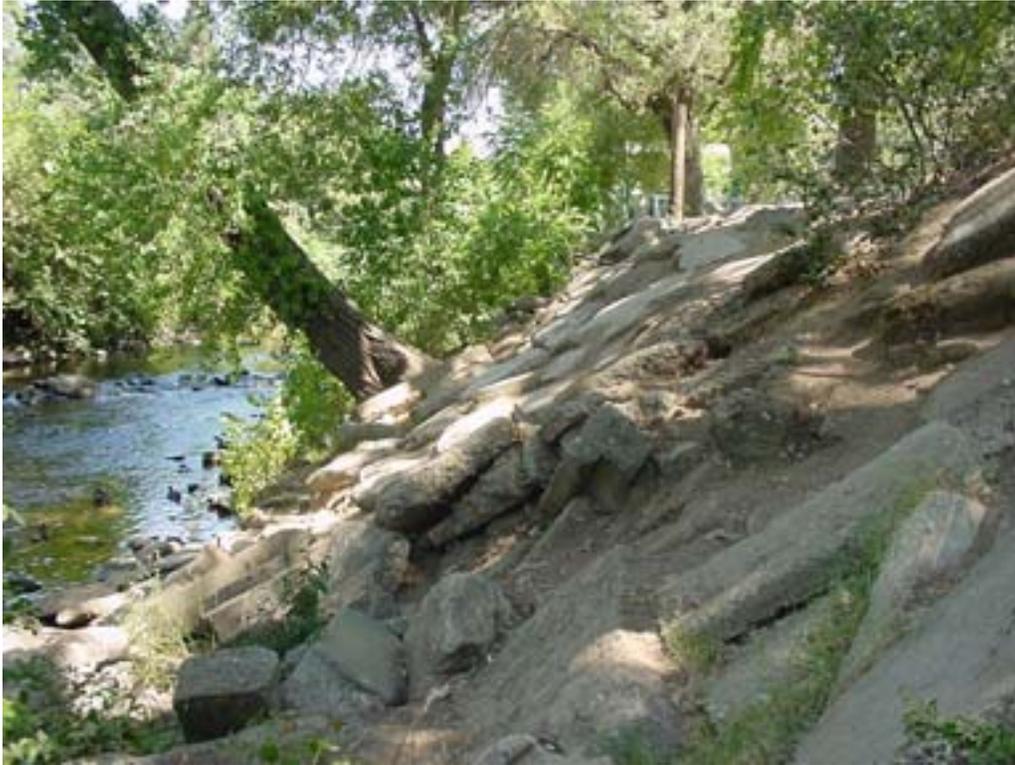
## Site 23L

- Located within straight, narrow, and steep reach
- Large-sized concrete rip rap with soil backfill in voids
- Rsp appears stable, but needs additional revegetation
- Sheet erosion at top of bank
- High pedestrian traffic

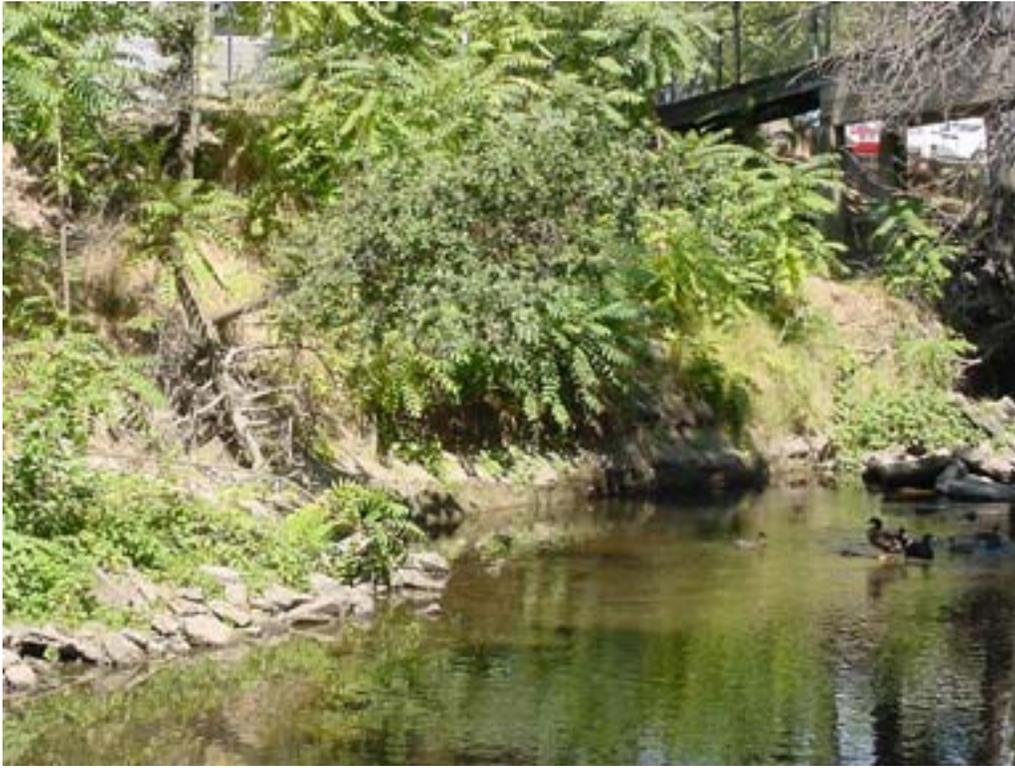
## Site 24R

- Located within straight, narrow, and steep reach
- Spotty placement of rip rap and rsp at toe and on banks is providing minimal protection
- Adjacent bridge location precludes widening
- Some well-established vegetation on upper banks

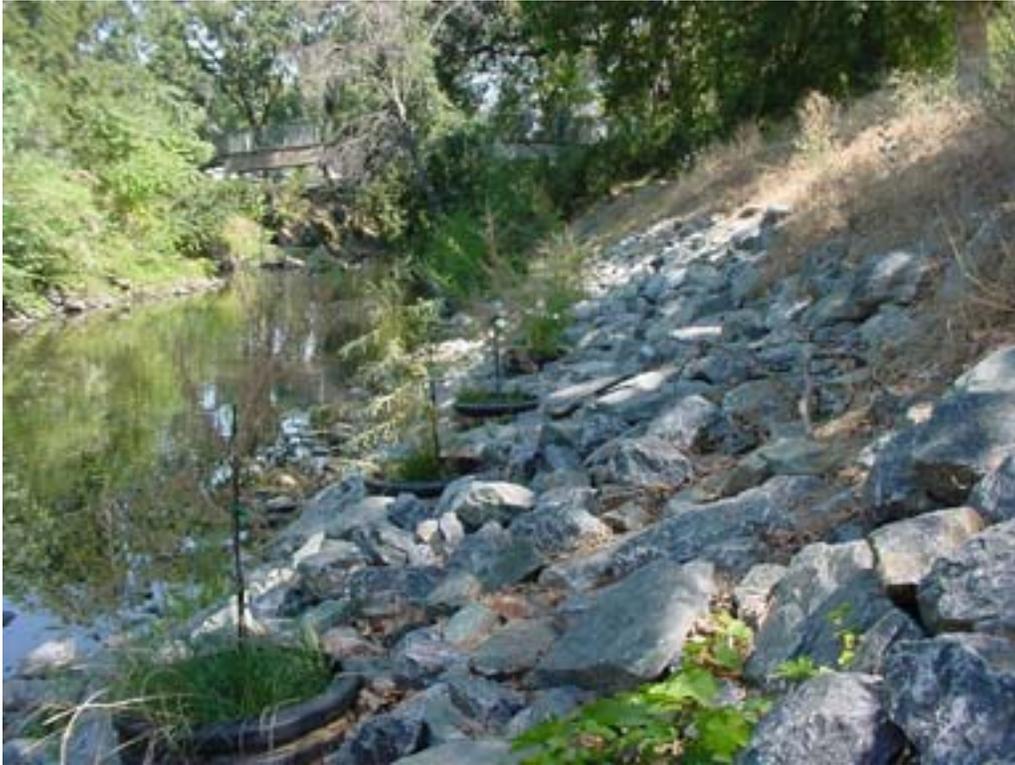
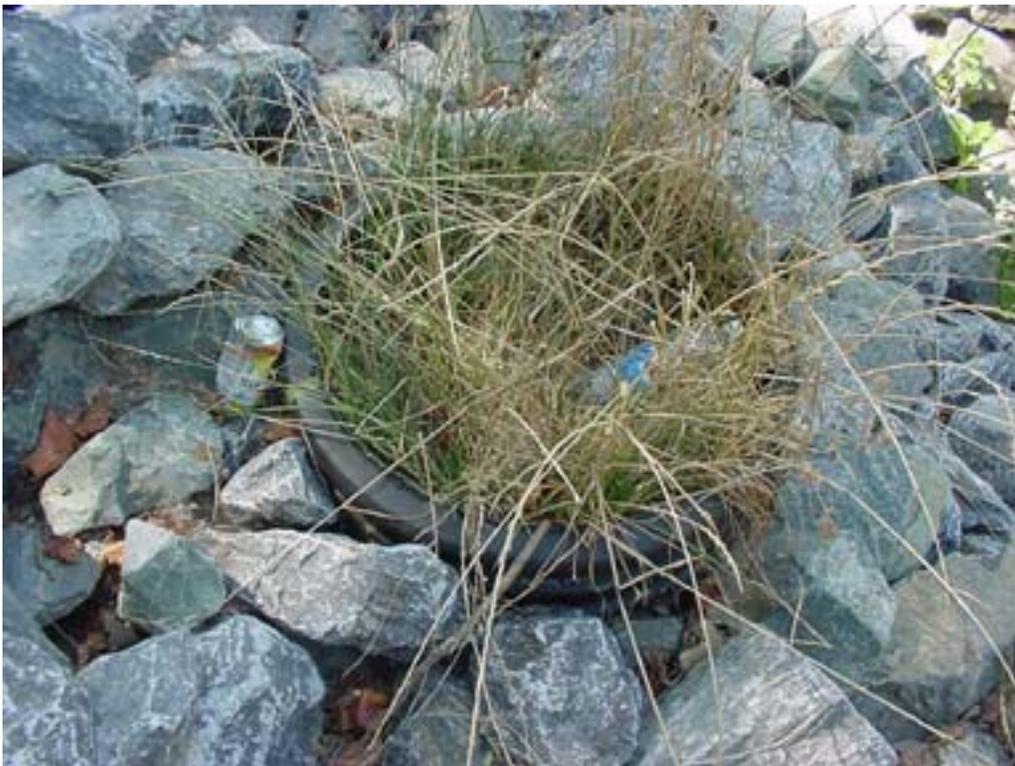
Site 25L

- Rsp appears stable with newly established vegetation
- Some revegetation efforts appear unsuccessful

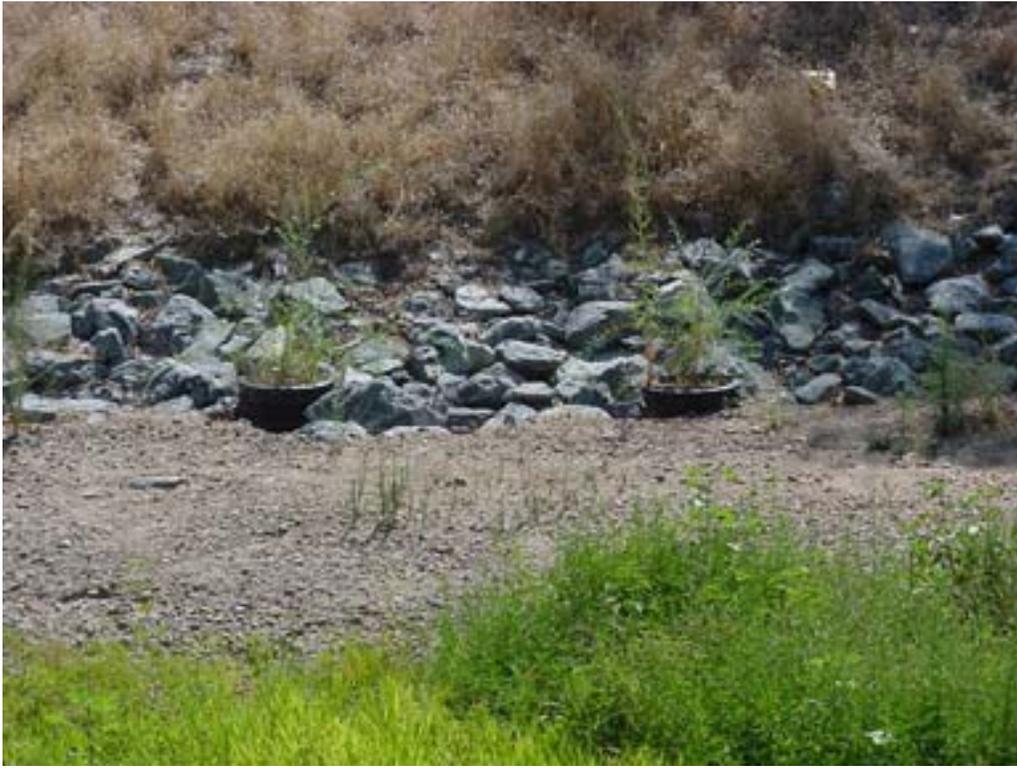
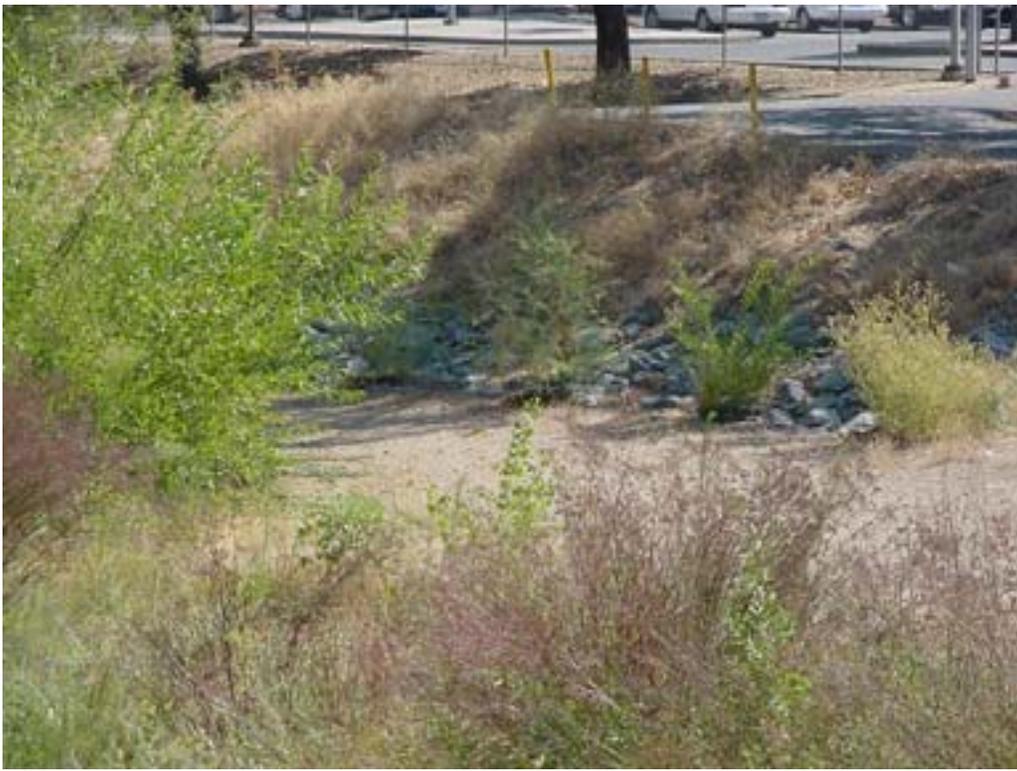
Site 28L

- Located within wide aggradational section
- Rsp appears stable
- Vegetation is established and appears to be doing well in containers

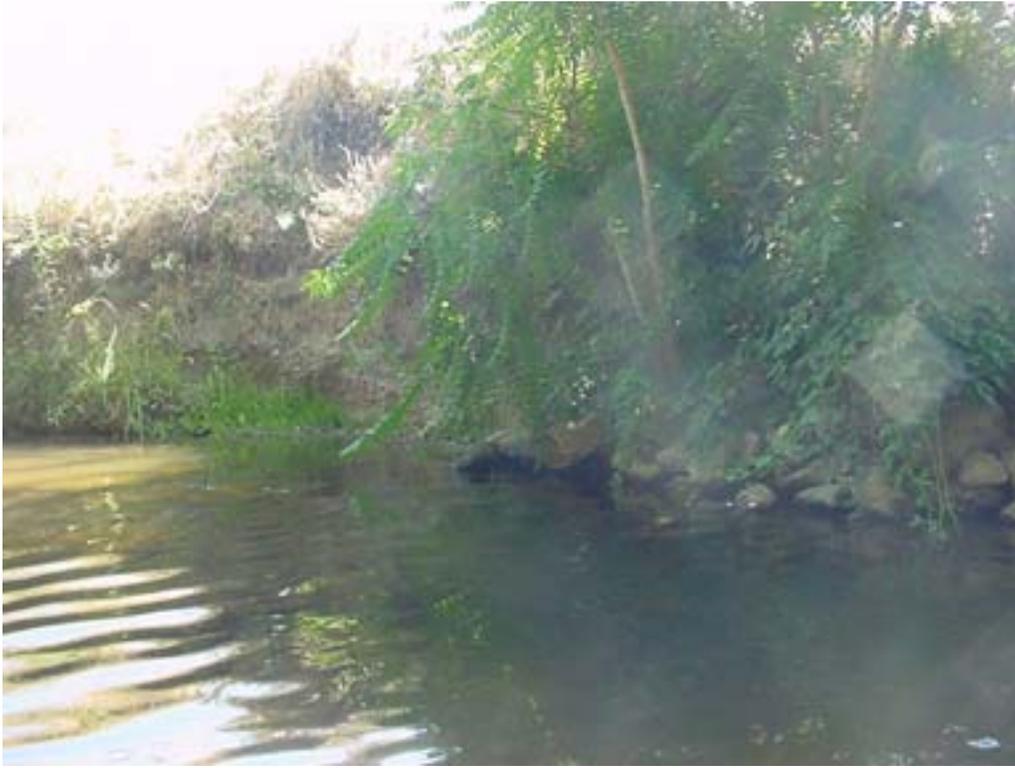
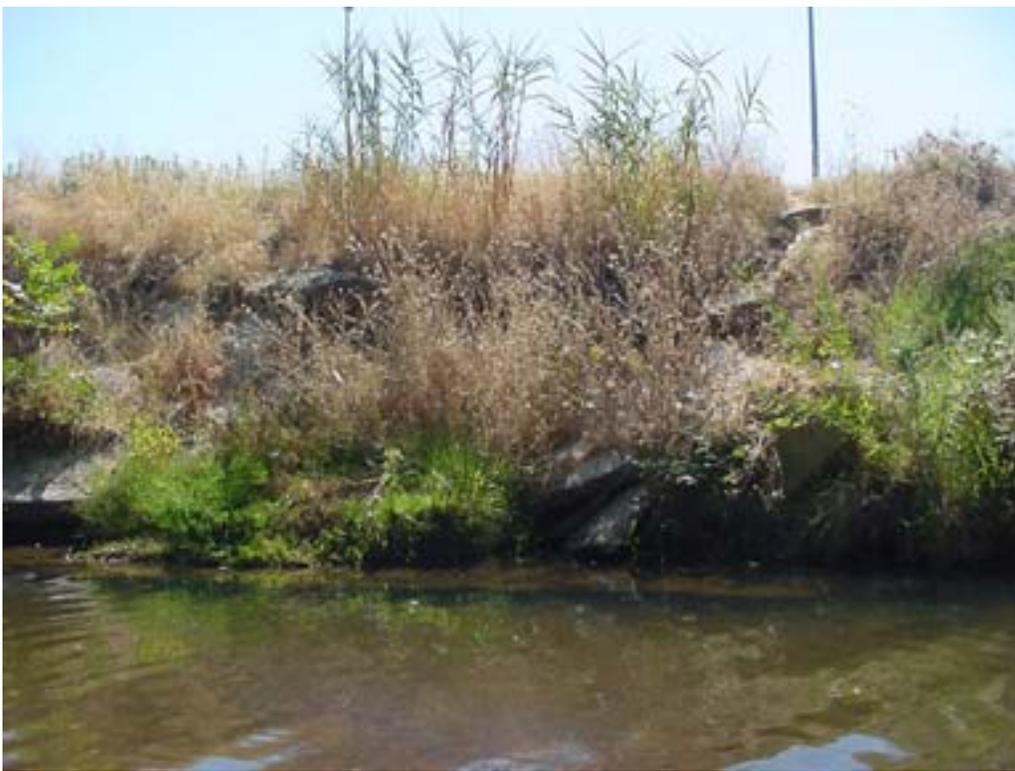
Site 30L

- Large chunks of rip rap used to armor the toe and mid-bank
- Rip rap appears to be failing, slumping in many locations
- Bank lacks mature riparian trees and has poor habitat complexity

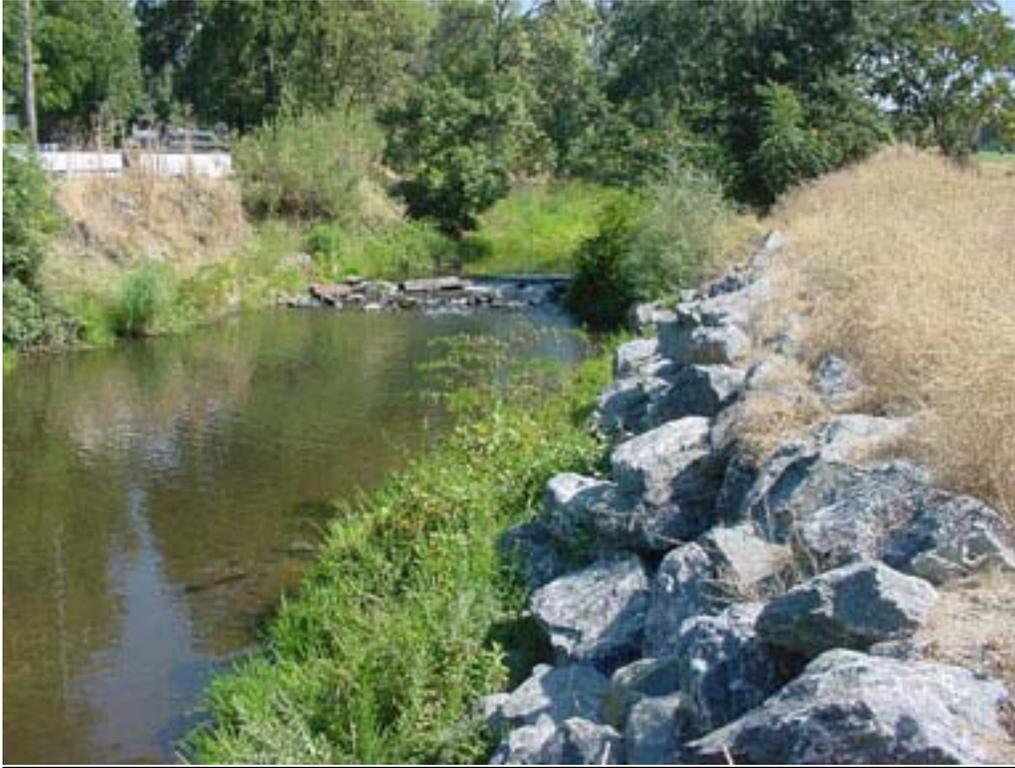
## Site 32L

- Large-sized rsp used to armor failing slope at location of old landfill
- Slope appears to be well-stabilized, with some vegetation recruited at toe
- Rsp voids contain no fines and have little chance of recruiting vegetation, as is
- Upper bank has not mature riparian trees

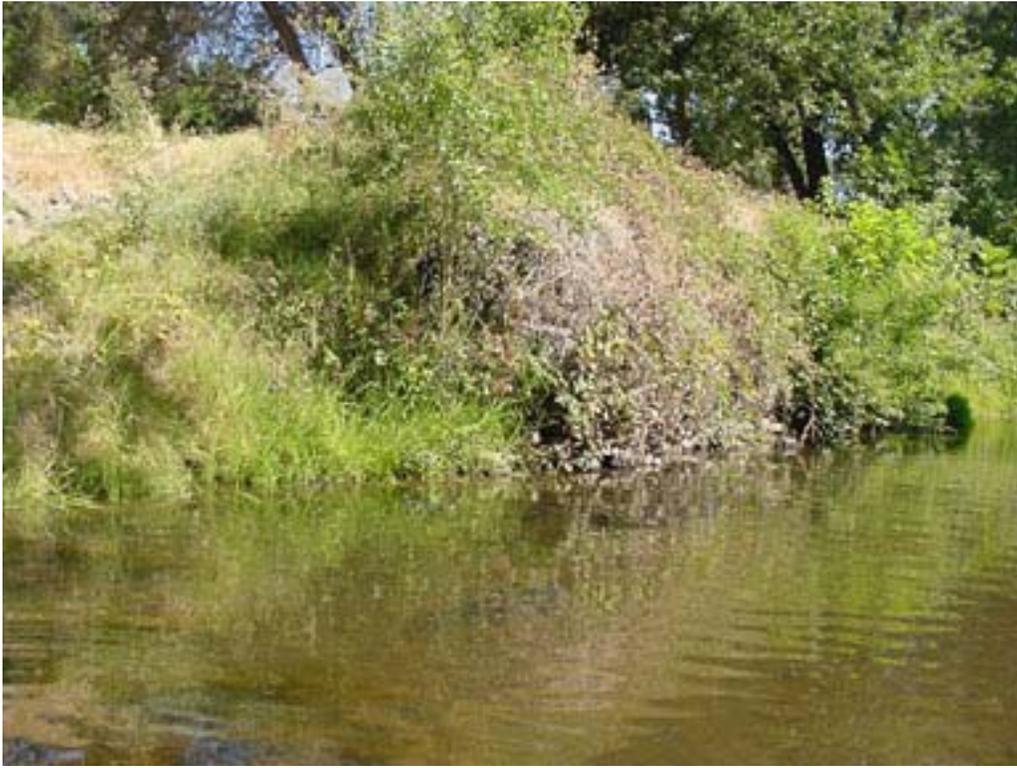
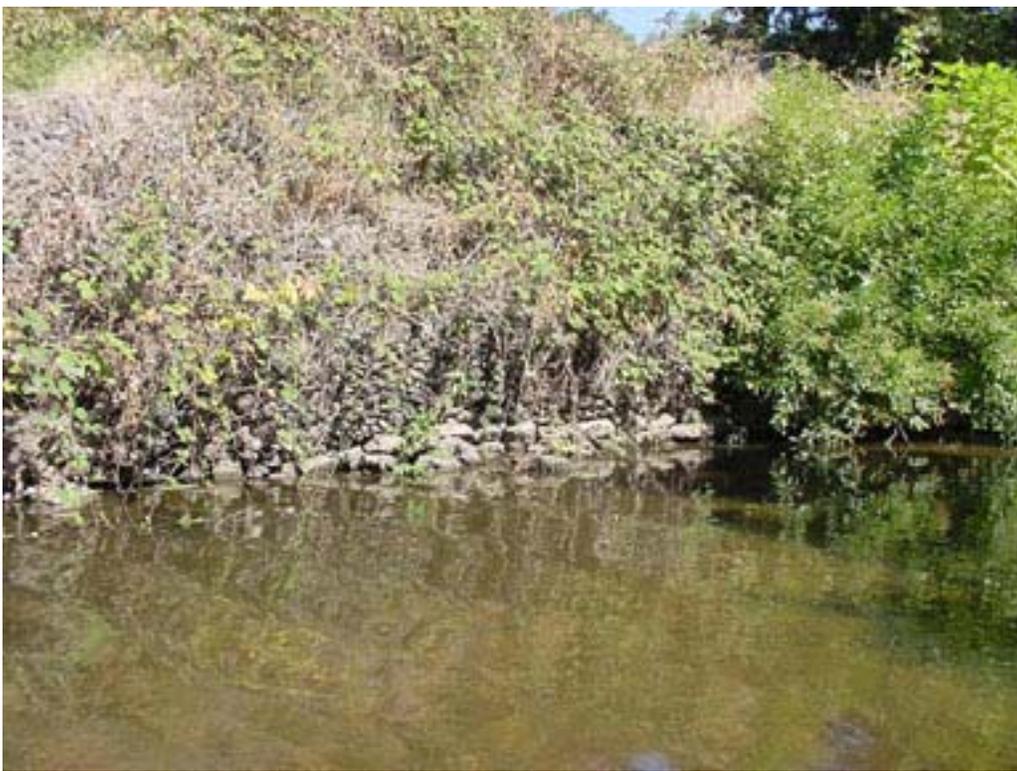
Site 33R

- Gabion wall primarily vegetated with exotic blackberries
- Wall is bulging at toe
- Appears to have a poor footing and was constructed with rounded cobbles

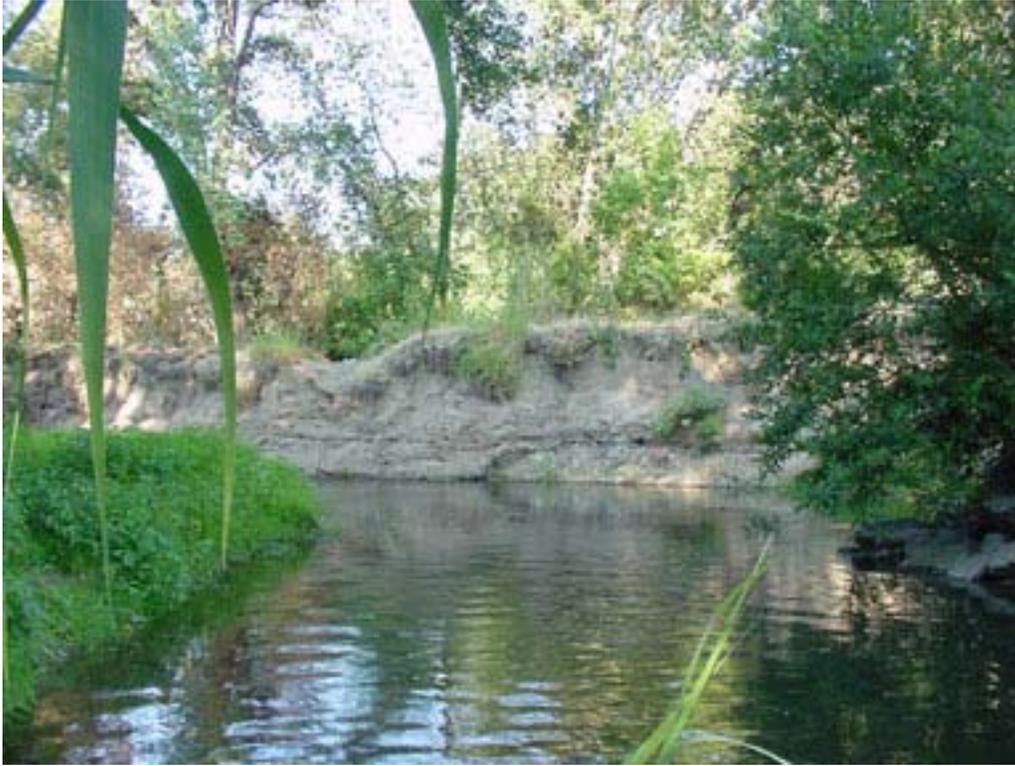
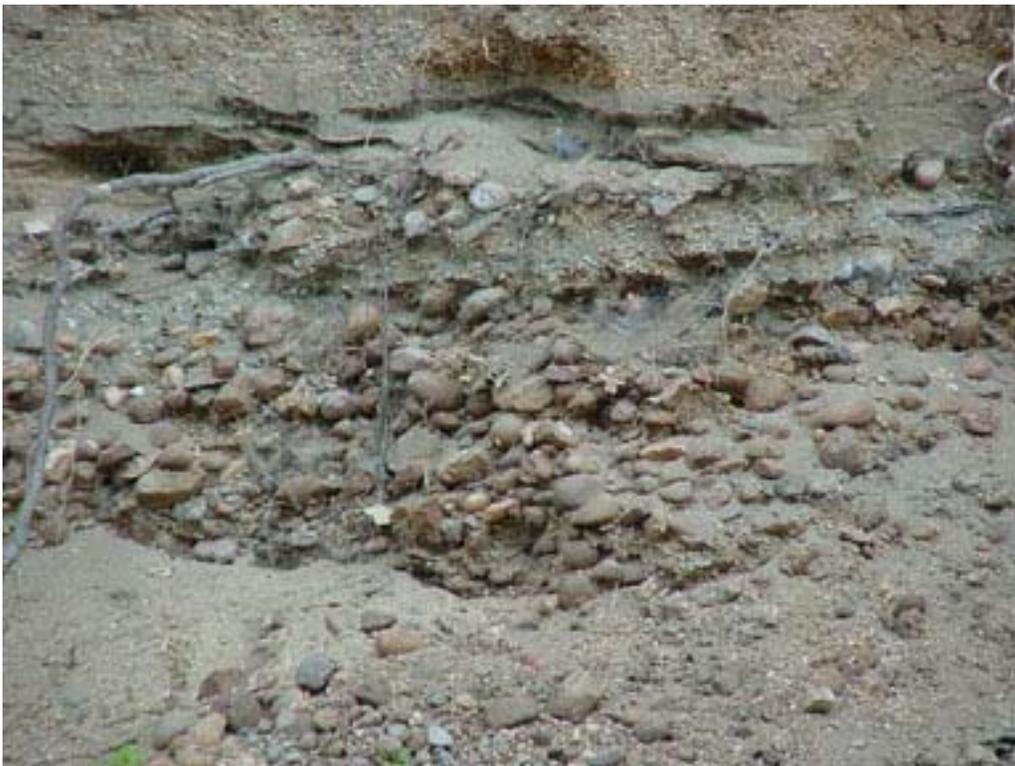
Site 39L

- Existing gabion structure flanked at upstream end (gabion wall at right edge of top photo, not visible.)
- Appears to have been constructed with inadequate transition at upper end, and located within a non-cohesive cobble layer

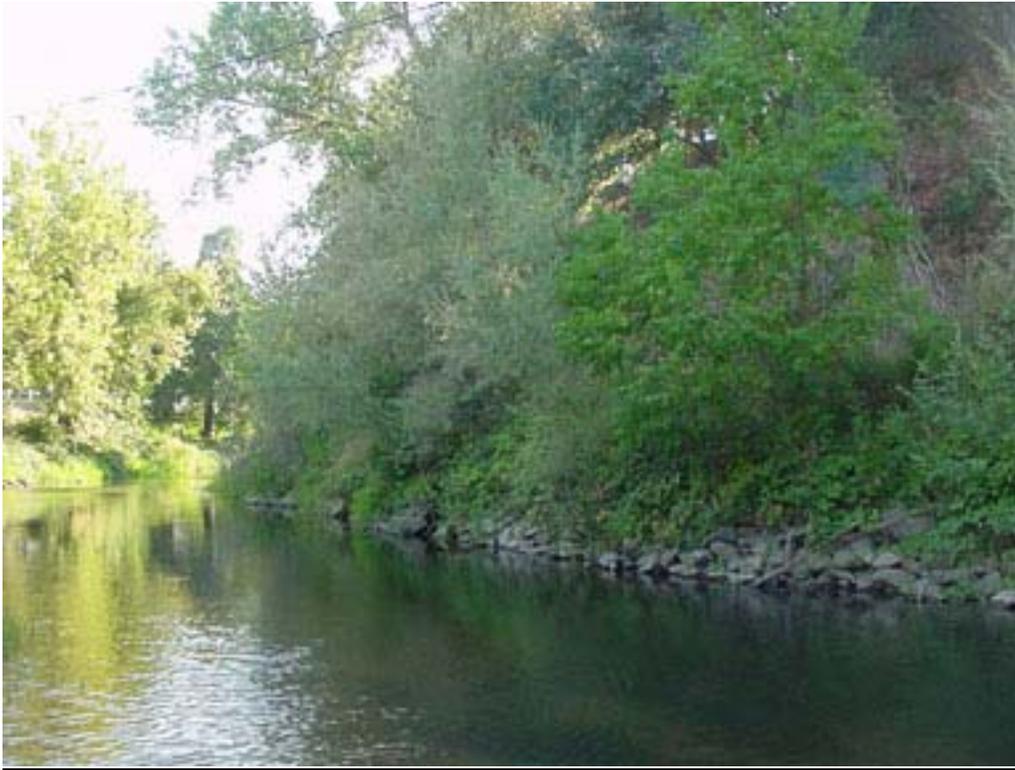
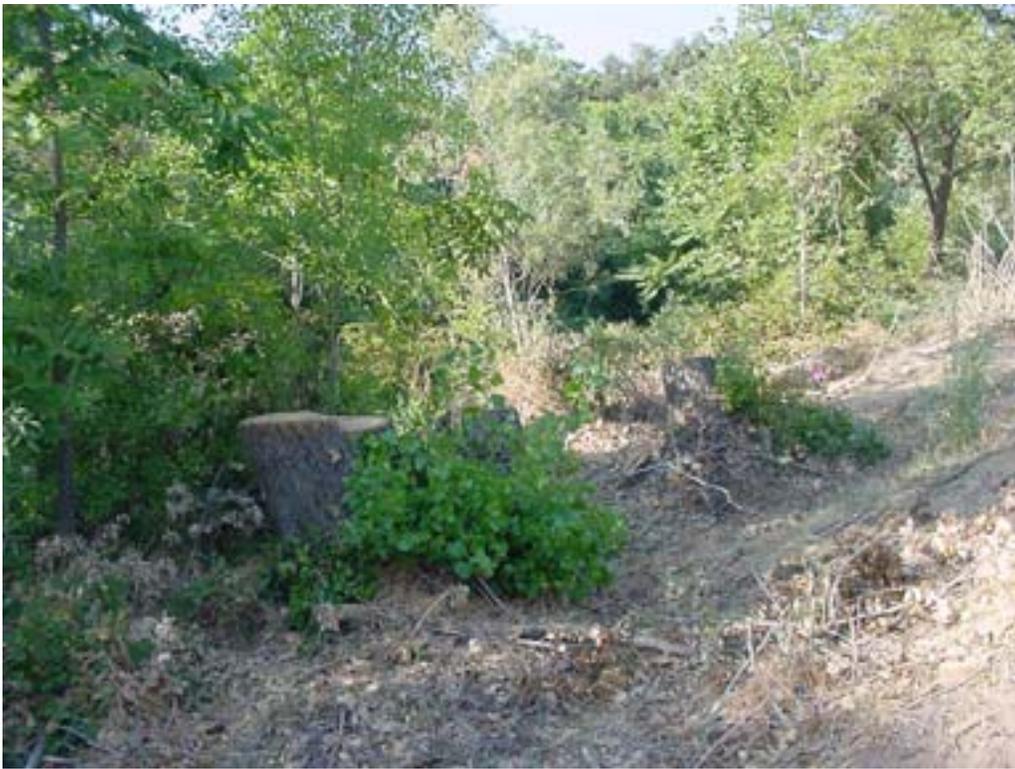
Site 41R

- Failing sackrete and small rsp located on mid-slope and toe
- Mature vegetation appears to be serving to stabilize slope
- Structure located at top of slope precludes expansion of section
- Opposite bank is lower, providing some floodplain relief
- Large cottonwoods being removed from opposite bank at time of survey
- There appears to be room to create additional channel capacity and to reduce erosive forces through excavation of bankfull floodplain on opposite bank

- Create bankfull floodplain on opposite bank and replace riparian canopy

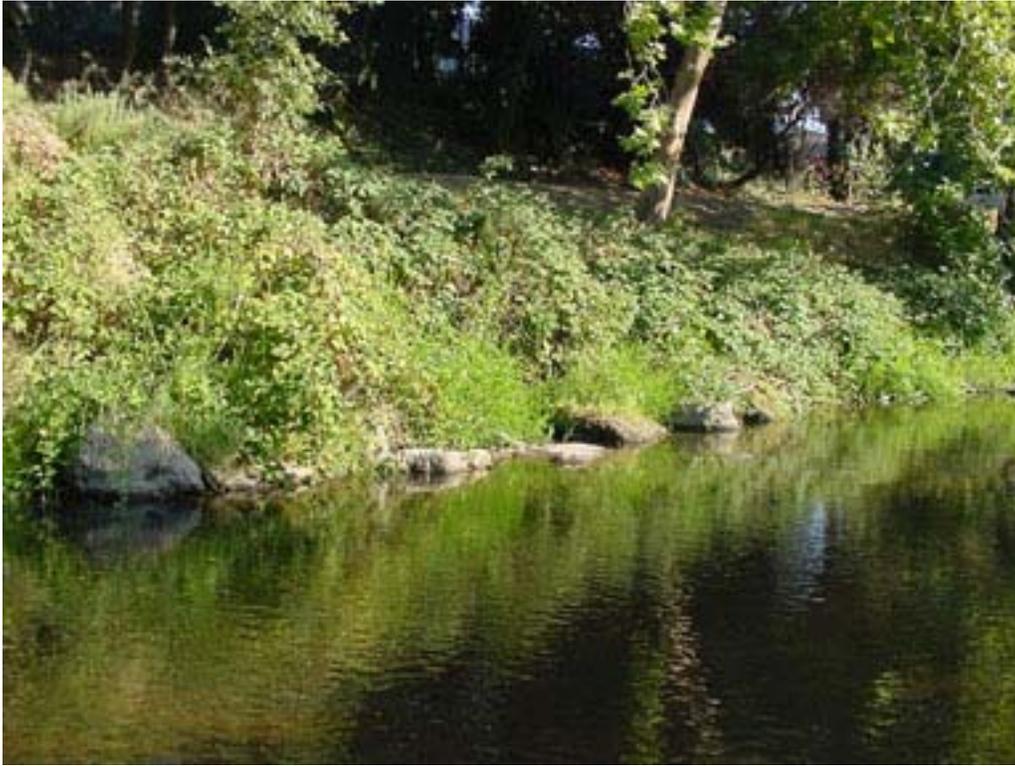
**Site 41L**

- Stable rip rap of 2-5 ft. diameter placed at toe of slope, below roadway
- Good groundcover established, but poor canopy
- Slope appears stable, but steep and constrained tightly by presence of roadway

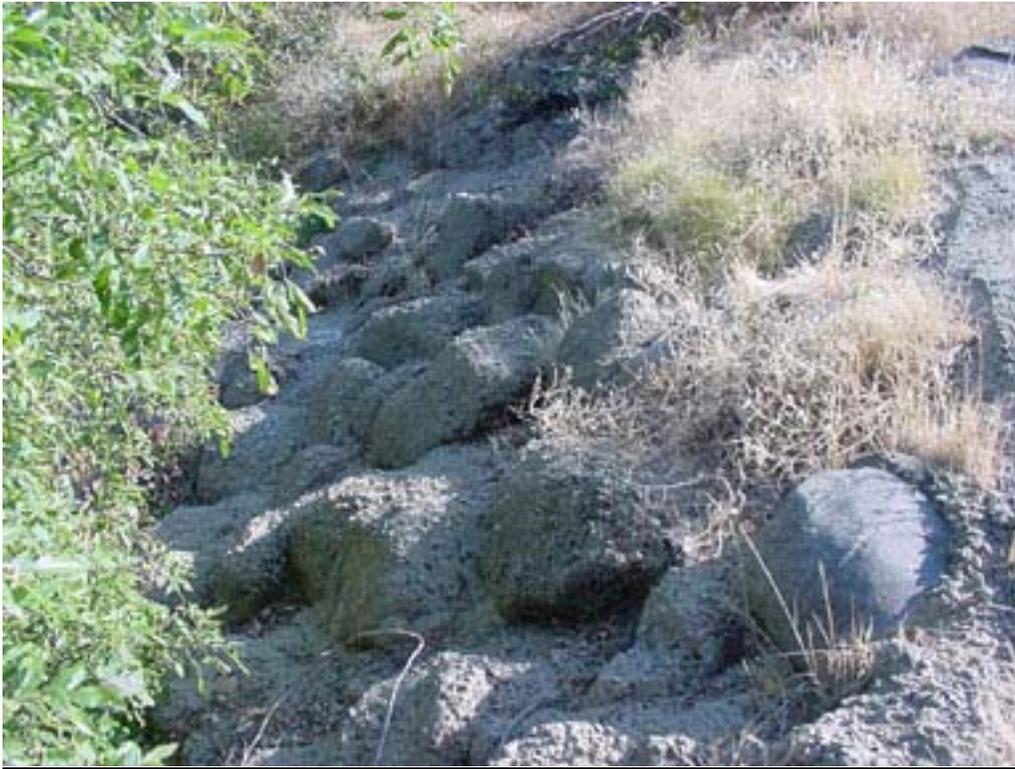
## Sites 44L/R

- Grouted rsp placed to protect sewer crossing
- Primarily stable, but undercut at ends with soil loss due to piping
- Zero revegetation opportunity
